Safety Defect and Noncompliance Report Guide for Equipment PART 573 Defect and Noncompliance Report (1)

07V-187 (18 pages)

(response) EZ Loader Custom Boat Trailer Swing-Tongue Option

Technical Service Bulletin

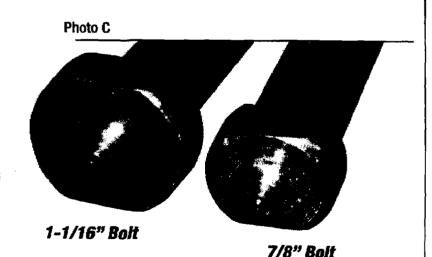
Step 2: Inspect your trailer and determine if the Pivot Bolt Assembly has the large (1-1/16 inch, See Right Photo) diameter head or the small (7/8 inch, See Right) diameter head with washer. If your trailer has the large (1-1/16 inch, Photo C) diameter head Pivot Bolt no further action is required.
