RE: Defect Information Report

Safety Recall Bulletin

Model	TUCSON (JM)
Group	AIR BAG SYSTEM
Number	HT-6-57-P03-JM
Date	April 5, 2007
Area	See Vehicles Affected below
Type	SAFETY RECALL

DRIVER AIR BAG MODULE REPLACEMENT

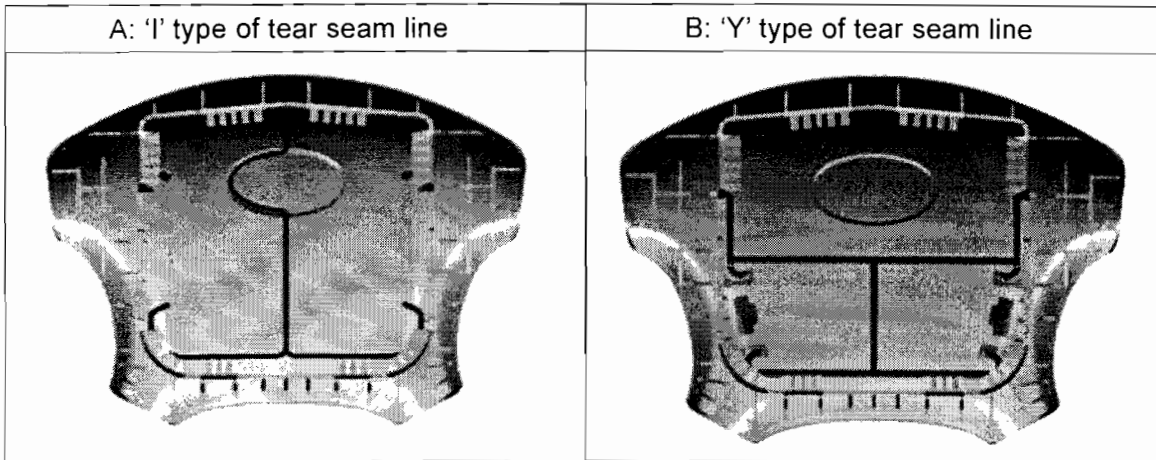
TUCSON (JM) driver air bag module had been produced with the **'I' shaped tear seam line (A)** on the cover. The driver air bag module must be replaced with new one with the **'Y' shaped tear seam line (B)** to increase the margin of compliance in the driver position fifth percentile female unbelted low risk deployment test.

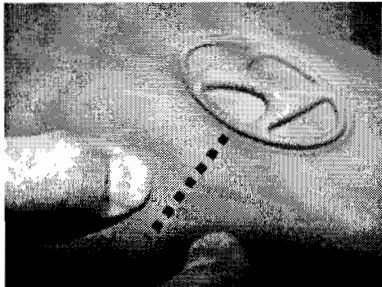
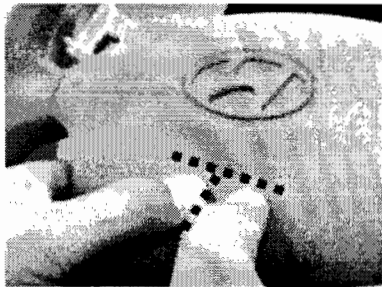
1) To discriminate between a previous DAB module and a new one, press the cover 20mm (0.8 in.) down from the 'H' logo. Previous DAB module cover can show 'I' shaped tear seam line and new one can show 'T' shaped tear seam line as shown in the pictures above.

-	56960-2E000U7QQH
	-	56960-2E000Z9QQH
