## **Re: Defect Information Report – Supplemental Report No. 4 07V-212, FL-496, TBB Warning Light Malfunction**

Subject: RECALL 07V-212 – Saf-T-Liner C2 Door Switch

Recall 07V-212

SUBJECT: IMPROVED AIR DOOR CONTROL OPERATION

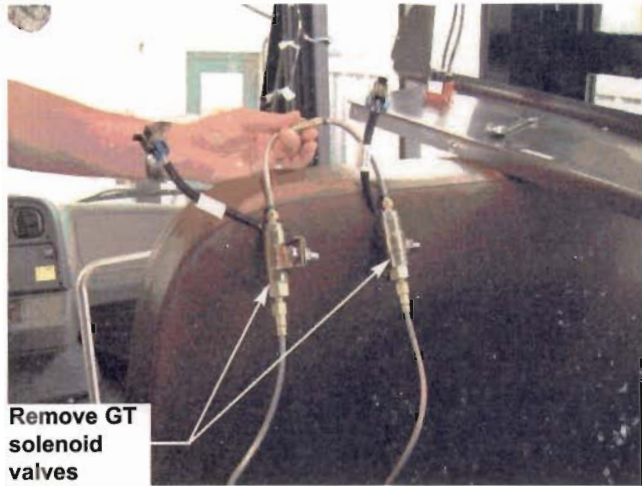
Figure 9

Remove GT solenoid valves

- 2.3 Remove solenoid valves. **Figure 1 and Figure 9**  
2.4 Remove existing switch bracket and micro-switch. **Figure 10**

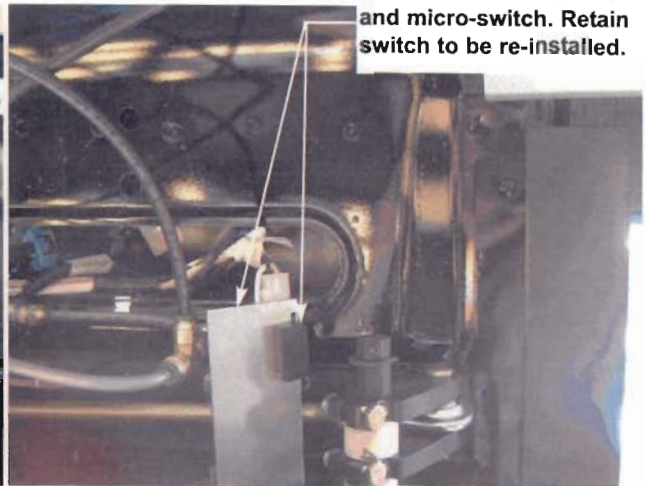
Figure 10

Remove switch bracket and micro-switch. Retain switch to be re-installed.

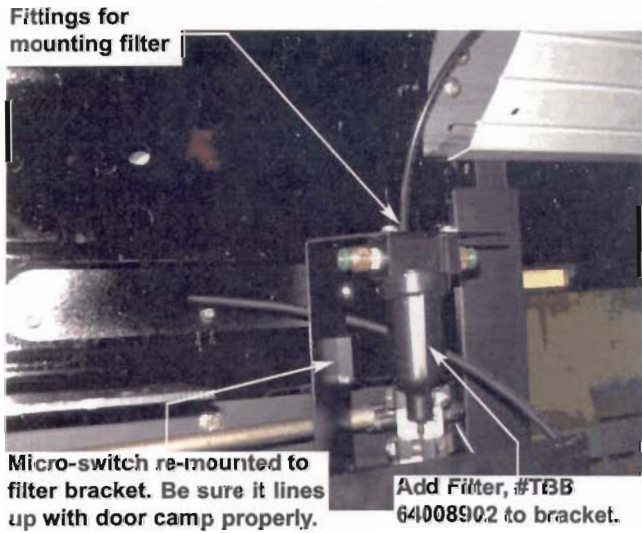
Figure 11

Micro-switch re-mounted to filter bracket. Be sure it lines up with door camp properly.

Add Filter, #TBB 64008902 to bracket.

- 2.5 Re-assemble micro-switch to Filter Bracket, #TBB 116536. **Figure 11**
- 2.6 Attach Inline Air Filter, #TBB 64008902 and #8 Flatwasher, #TBB 69004271, #8 Lockwasher, #TBB 61370346 and Machine Screw, #8-32 x .50, #TBB 61370396. **Figure 11**
- 2.7 After you have removed the valve assembly as shown in **Figure 1**, drill new holes in the mounting plate to accommodate the Parker Valve Assembly, #TBB 136969. **Figure 12**

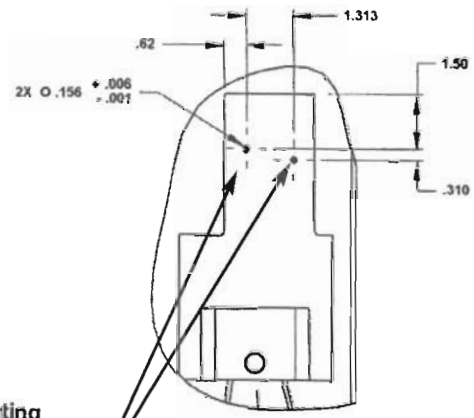
Figure 12

New mounting locations for Solenoid Valve, #TBB 136969.

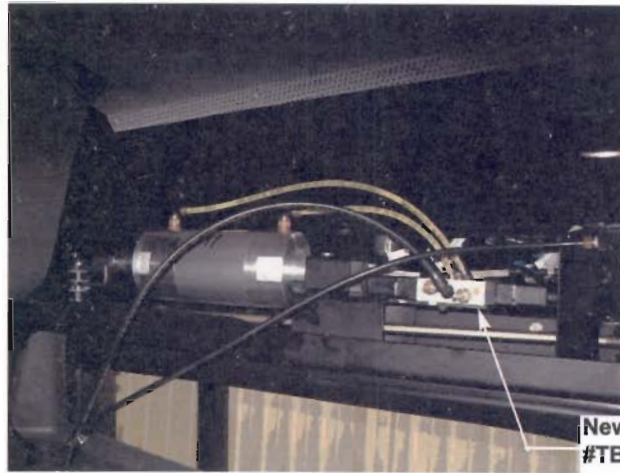
Figure 13

New Solenoid Valve Assembly,  
#TBB 136969

- 2.8 Assemble new Solenoid Valve, #TBB 136969 using Machine Screw, 6-32 x 1.25, #TBB 69002253 and Nylon Locknut, 6-32, #TBB 69004247. **Figures 13 & 14**
  - a. Remove the Opening Port fitting, and discard.
  - b. Install new Elbow Fitting #TBB 69008054 for the new valve to accommodate the 1/4 tubing.

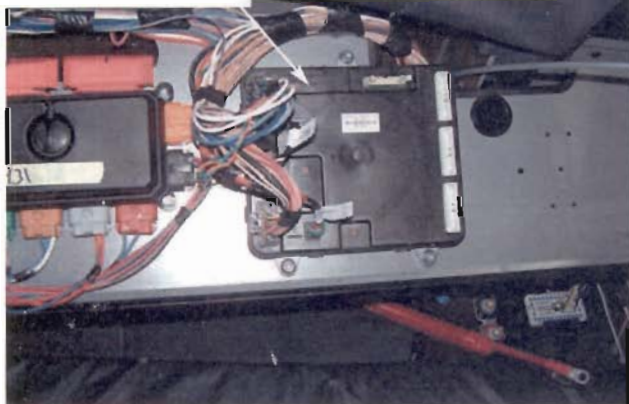
Original orientation of SHM

7. Reconnect the connectors to the SHM. See Figure 3 shows the original orientation of the SHM.
8. Rotate module 180°, installing it upside down with connectors face down, using Hex Flange Bolt, #TBB 29890014 and Hex Nut, #TBB 105826. Figure 4 shows new orientation of SHM.
9. Reinstall the rubber flap which was removed in Step 3.
10. Reinstall switch panel and harness.

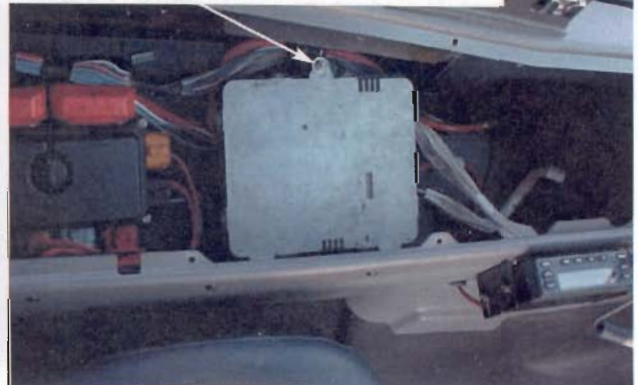
Figure 4

New orientation for SHM  
Hex Flange Bolt, #TBB 29890014,  
Serrated Flange Hex Nut, #TBB 105826

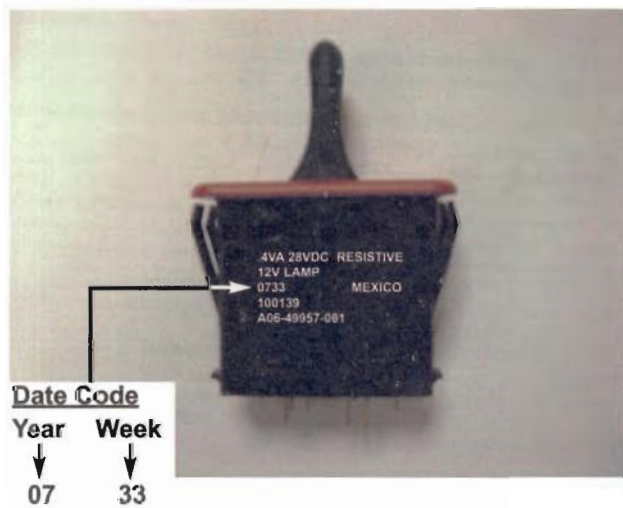
**Note:** If door switch Date Code is pre-September, 2006 (0636), switch must be replaced. See Figure 7 for an example of switch and location of the date code. Any switch with a Date Code prior to 0636 needs to be replaced, i.e. 0635, 0634, etc. Also, be aware that not all switches have the Date Code printed on the side as shown in Figure 7. Some of the early switches are 'engraved' on the front side (narrow side) of the switch on the "DOOR OPEN" end.

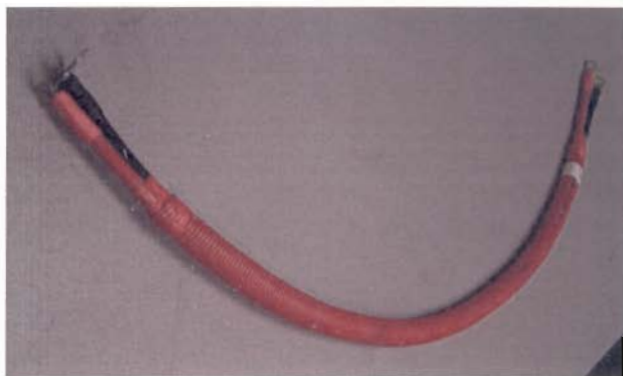
Figure 9

6. Remove cable from the vehicle to begin the following modifications. (Figure 9) **Note: Stock cable has the power and ground wire bundled together.**
7. Remove and discard the convoluted tubing from the cable bundle to separate the power and ground cable as shown in Figure 10.
