RECALL MANAGEMENT DIVISION

07V-231  
(11 Pages)

Ref: Kalmar Industries Models Ottawa 4x2 and 6x4 DOT/EPA

## PROCEDURE FOR IDENTIFYING AND REPLACING SEAT BELT TETHER

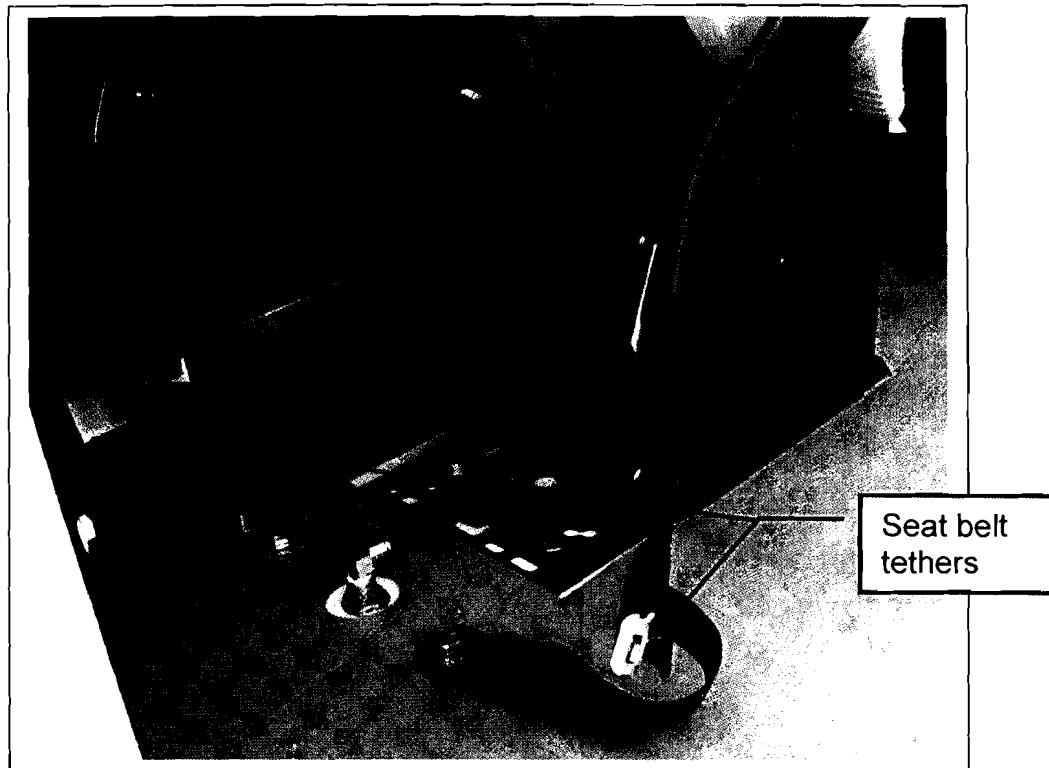
Figure 1

1. Locate the tethers on both sides of the seat. The tethers are the portions of the seat belt that are attached to the seat frame and the floor of the cab. See figure 1.

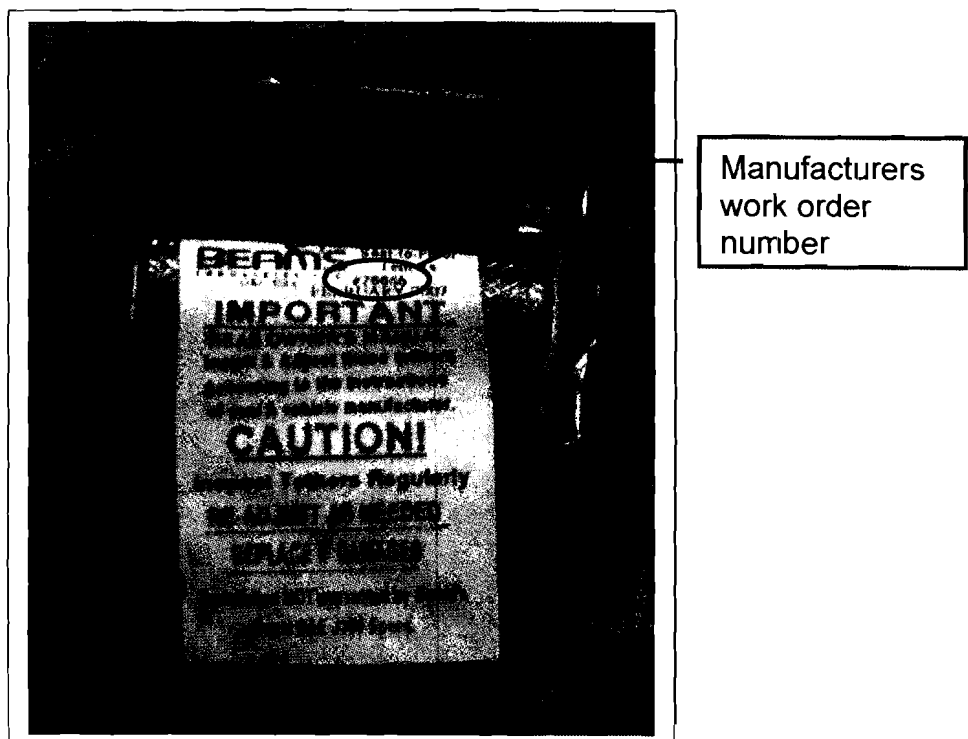
Figure 2

2. Turn the tether until the identification tag is legible.
3. Locate the manufacturer's work order number on the identification tag. See figure 2. If the number is 79361, then contact Kalmar Customer Service for replacement parts kit part number 53575634 and continue to steps 4 thru 7. If the number is **NOT** 79361, then replacement is not necessary.
