DEFECT INFORMATION REPORT FOR DAIMLERCHRYSLER CORPORATION RECALL G14

Safety Recall G14

Seat Track Position Sensor

2007-2008 (JS) Chrysler Sebring and Dodge Avenger

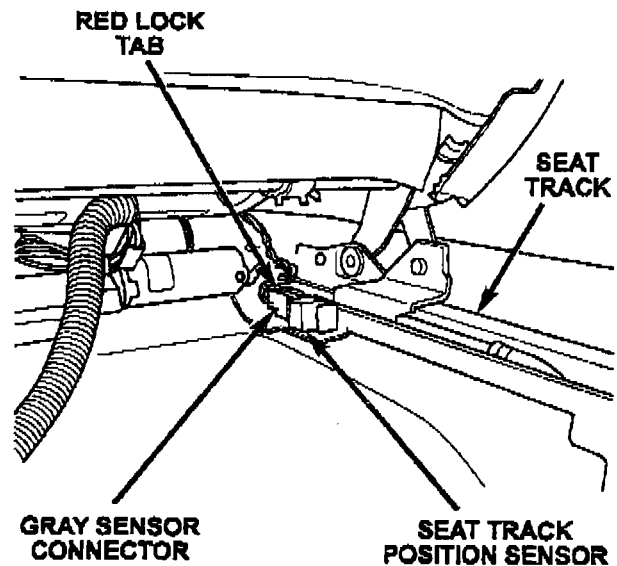
Figure 1 – Backside of Driver's Seat View

2. For four door models, place the driver's seat in the full forward and full up position.
3. For convertible models, place the driver's seat in the midpoint and full up position.
4. For four door models, locate the seat track position sensor on the seat track. Slide the red lock tab forward on the gray electrical connector (Figure 1).
5. For convertible models, locate the seat track position sensor on the seat track. Use a cotter pin removal tool (Snap-on CP3B or equivalent) to push the red lock tab forward on the gray electrical connector (Figure 2).
6. Disconnect the gray sensor electrical connector by pressing down on the red connector lock tab while pulling the connector forward..

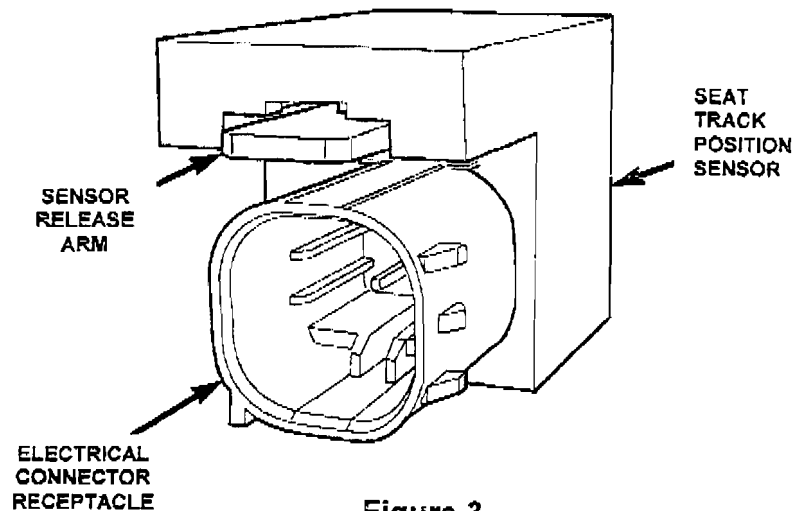
Figure 3

7. Remove the seat track position sensor from the seat track by pressing on the sensor release arm while pulling the sensor forward (Figure 3).

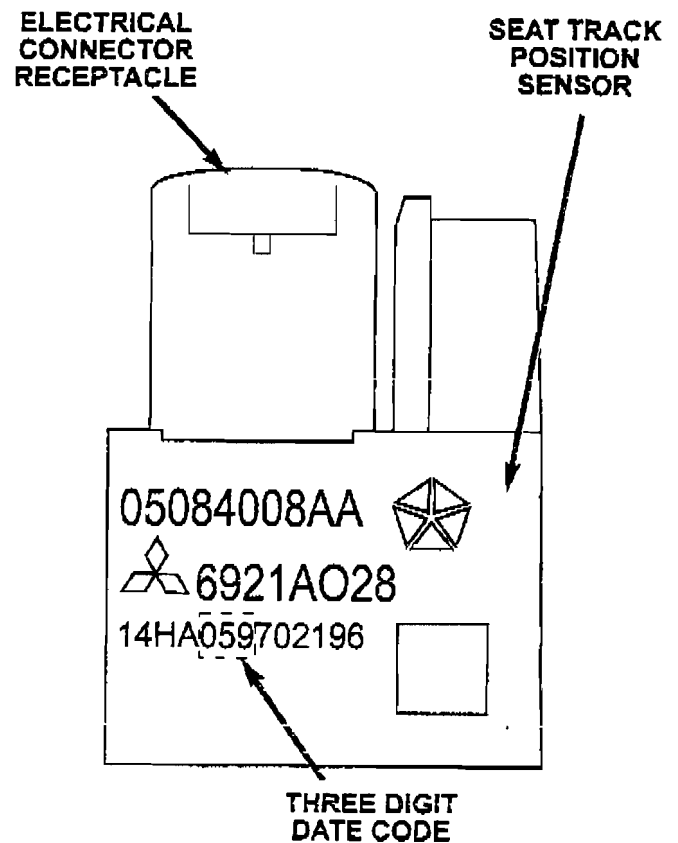
Figure 4

8. Check the date code on the seat track position sensor (Figure 4):

- If the date code on the sensor is 099 or lower or 107 or higher, the sensor is good.
- If the date code on the sensor is between 100 and 106, the sensor must be replaced.
