DEFECT INFORMATION REPORT FOR DAIMLERCHRYSLER CORPORATION RECALL G14

Safety Recall G14

Seat Track Position Sensor

2007-2008 (JS) Chrysler Sebring and Dodge Avenger

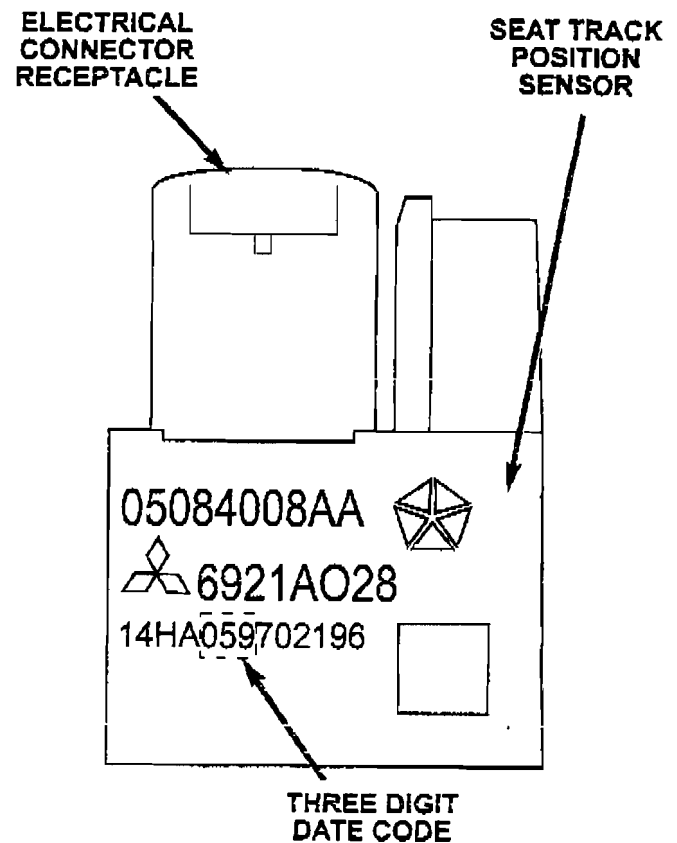
**Figure 4**

- If the date code on the sensor is 099 or lower or 107 or higher, the sensor is good.
- If the date code on the sensor is between 100 and 106, the sensor must be replaced.

8. Check the date code on the seat track position sensor (Figure 4):
