## **PART 573 DEFECT AND NONCOMPLIANCE**

Supplemental answer to II.

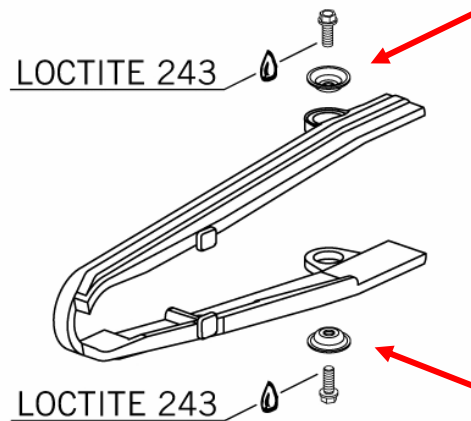
There was a material change on the cupped washer from carbon steel to stainless steel that caused the cupped washer to have less depth than the formerly produced cupped washer. Therefore, the cupped washer is not fully pressed against the swingarm and affects the bolt torque which may result in the chain slider mounting guard becoming loose.

The beginning date of manufacturing for the defective chain slider guard mounting began July 15, 2006. This production date marked the beginning of the 2007 Adventure and Superenduro models and remained in defective production until May 14, 2007, when the problem was identified and cured at the manufactures facilities. No further produced models suffer the deficiency.
