**07V-268**  
**(18 pages)**

Subject: **Safety Recall – Steering U-Joint Assembly - New Flyer Part Number 8112157.**

**INSTRUCTION TO SERVICE ITS: 3306**

OBJECTIVE/SUBJECT:  
Inspect and replace U-Joint Assembly.

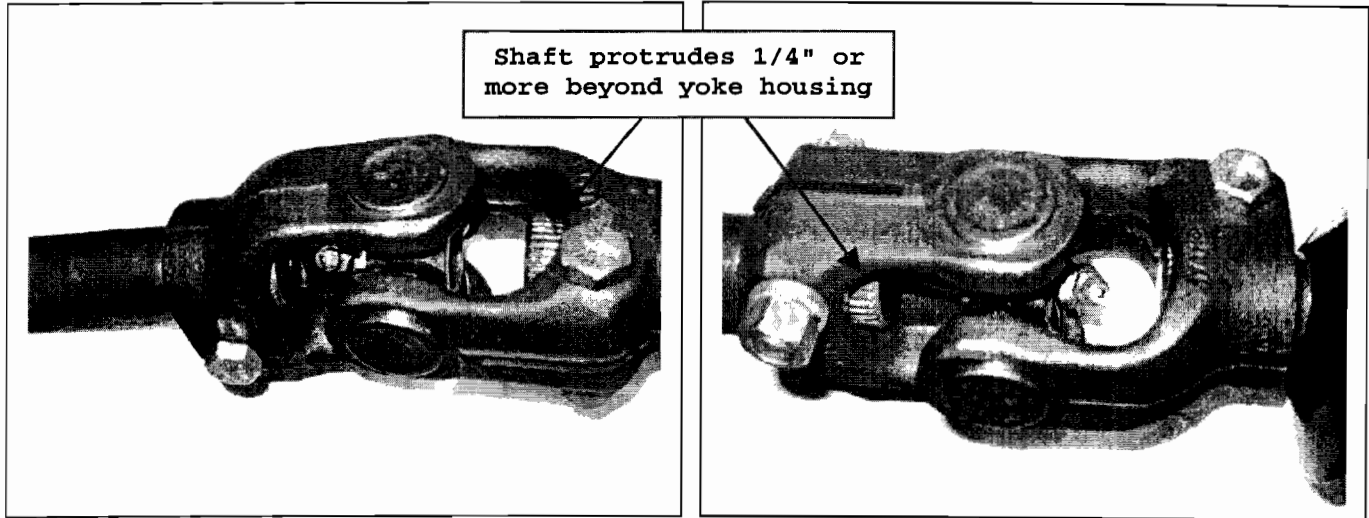
The U-Joints supplied by Buffalo Industries have poor spline engagement on one of the two end yokes of the assembly to the attaching component. Buffalo Industries builds the U-Joints from Dana-Spicer sub-components, to the design criteria supplied by New Flyer Industries. The Buffalo Industries U-Joint, as delivered to New Flyer, have been determined to not be built to New Flyer design criteria, and may result in premature wear of the splines.

Remedy component has full spline engagement with both shafts of the mating components.

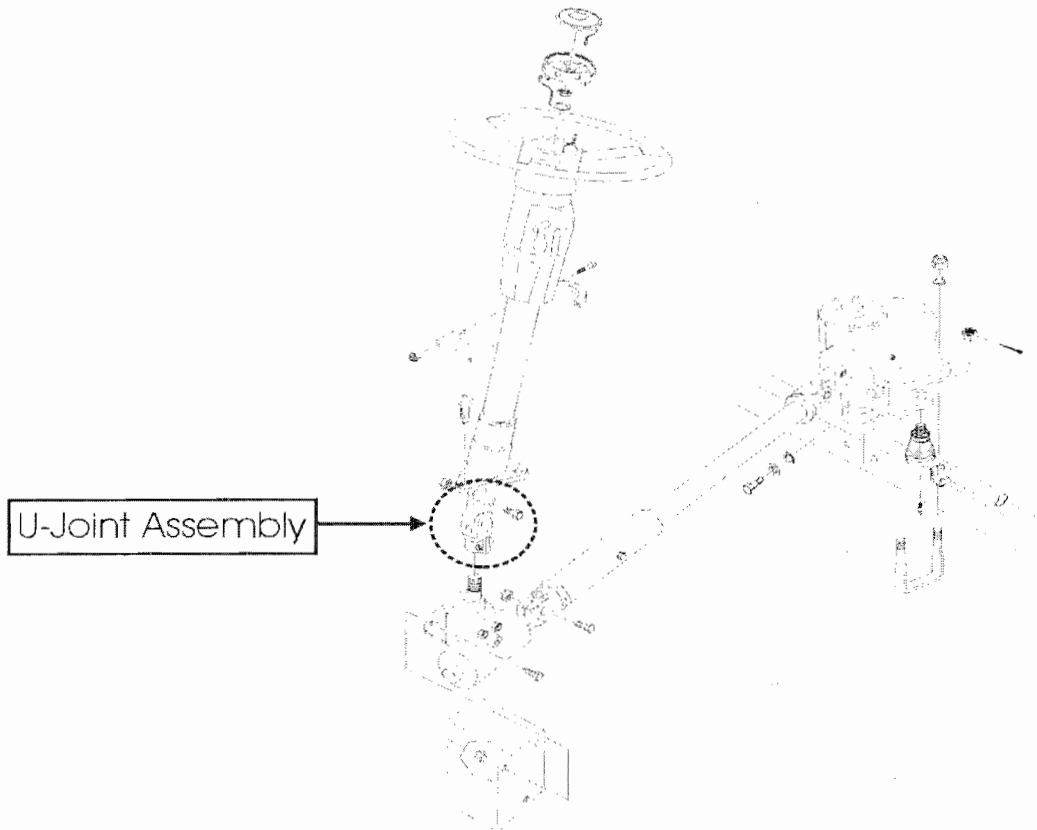
Figure 1:

2. Locate U-Joint Assembly as shown in Figure 1.

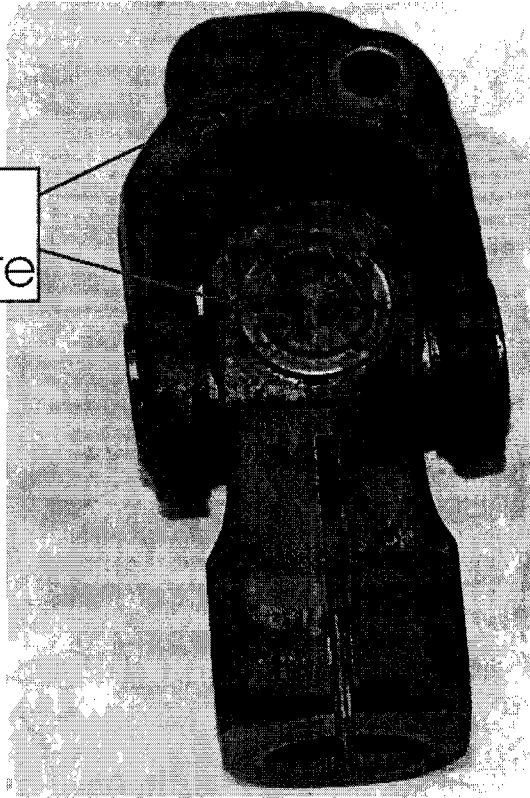
Figure 2:

3. Inspect U-Joint Assembly. If either or both of the following are present, U-Joint Assembly must be replaced, otherwise skip to step 10:
  - a. "Spicer" logo stamped on the U-Joint. See Figure 2.
  - b. One splined shaft protruding  $\frac{1}{4}$ " or more beyond yoke housing at end where offset bolt is located. See Figure 3.

"Spicer" logo stamped here

4. Install new U-Joint Assembly (PN 8112157) as required. Torque bolts between 30 to 35 ft-lbs.
5. Check for worn splines on the steering column and transfer gearbox by grasping the U-Joint Assembly by hand and twisting it back and forth.
6. If splined connection is too loose between steering column or transfer gearbox, replace components as required.

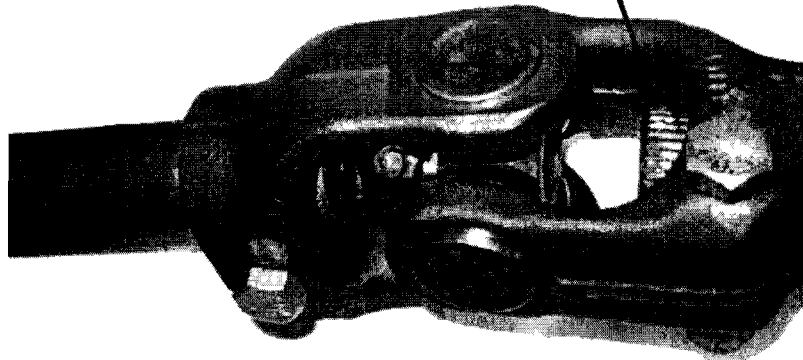
Figure 3:

Shaft protruding into yoke housing
