General Motors Overseas Distribution Corporation (Singapore)

Submission of Report 573

The following information is submitted pursuant to the requirements of 49 CFR 573.6 as it applies to a determination by GM Daewoo Auto & Technology Company of a safety defect involving certain 2006 and 2007 Chevrolet Optra model vehicles.

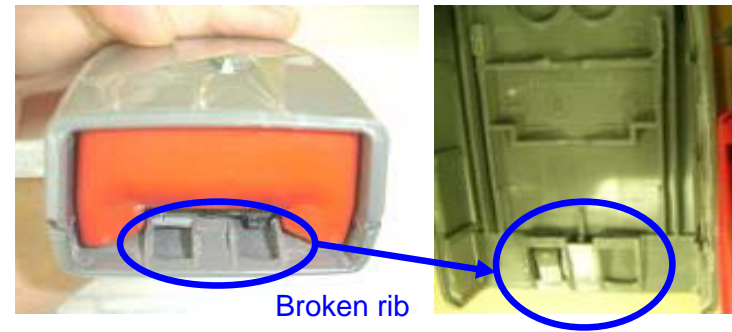
Date of manufacturing May.6, 2005 ~ Dec.20, 2006		VIN. KL5JJ56ZX6K999346 ~ KL5JD66Z37K596663										
Defective percentage 0.8%(678 cases of 84,895 vehicles)		Mileage										
② Findings 1.Defective Parts-2.Process-3.Standards-4.Drawings-5.4M(man, machine, material, method) -6.Reproduction Test-7.Records of Defective Parts or Defective Lot -8.Forecast and reasons for frequent occurrence of the defects - Defective parts . Buckle A-FRT Seat belt LH/RH - Process: NOK . Stock Material(sub part) → Assembly base to function part → *Ultrasonic welding(lower cover to upper cover) → Inspection → Packing → Delivery to vehicle assembly line * Improper ultrasonic welding process made stress to base ribs in the lower cover. - Standards: OK . No abnormal performance - Drawings: OK . No remarkable fault - 4M history : OK . There was no 4M change - Reproduction Test: OK . Broken fixation rib were observed on a misuse test. Misuse test was newly designed to accelerate test. - Forecast and reasons for frequent occurrence of the defects . 0.8% field incident rate from field vehicles. . 82% blocked button and 5% sticky button was observed from the 204 field claim parts.				③ Causes for problem - Improper ultrasonic welding process at supplier made stress to fixation rib & spring rib so that it could be broken by continuous stress during customer use. . Standard : Buckle upper cover must be positioned on lower cover . Actual : Buckle upper cover is located below lower cover			⑤ Countermeasures to prevent recurrence of the same problem - Changed buckle Cover ultrasonic welding process. . Before : Buckle lower cover is on Buckle upper cover . After : Buckle upper cover is on Buckle lower cover - Break point: Dec.20,2006 (KL5JD66Z07K597169-) <div style="display: flex; justify-content: space-around;"> <div style="text-align: center;"> Before : Ultrasonic welding

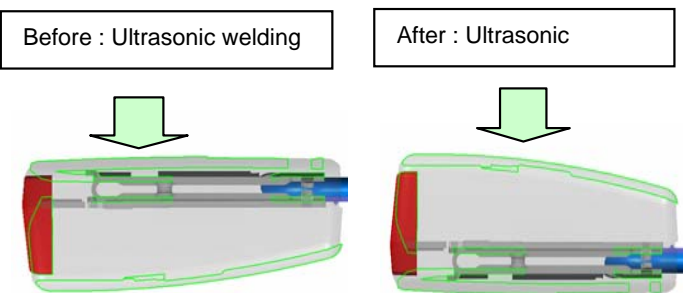
</div> <div style="text-align: center;"> After : Ultrasonic

</div> </div>			⑦ Confirmation Effectiveness of Countermeasures: : Same problem(Spring & fixation rib broken) was not recurred. Checking method : Visual check to the damage of buckle lower cover. Result of Checking : No damage was found from the new welding process produced buckle lower cover. Checking date : Dec.12,2006 Checking person : Hyunchol Jeong

④ Causes why Problems were not prevented . Insufficient FMEA for ultrasonic welding methods				⑥ Corrective measures to prevent the occurrence of the same problem - Added 0.3 radius to prevent fixation rib broken : Apr.28, 2007 - Changed design of buckle lower cover : Jun.15, 2007 (Spring rib & Fixation rib deleted) . To change part number for design change part by Sep.15,2007 - Driver side: 96800899 → 96875272 - Pass. side: 96800982 → 96875274			⑧ Reflection to Similar Parts / Similar Processes . None	
Application	Issuing Section			Quality Assurance				Comments by Quality Assurance . GMDAT EFADC authorized USA vehicles product safety recall to Suzuki on July 13, 2007. . Parts required for the recall will be supplied to the USA around November, 2007				
	Staff	Manager	S.Manager	Staff	Manager	S.Manager	Director					
					S.M Lee	I.H.Cho
