**07V-333**  
**(3 pages)**

**Re: Defect Information Report FL-507, St. Thomas Axilok Nut Damage**

## Defect Information Report

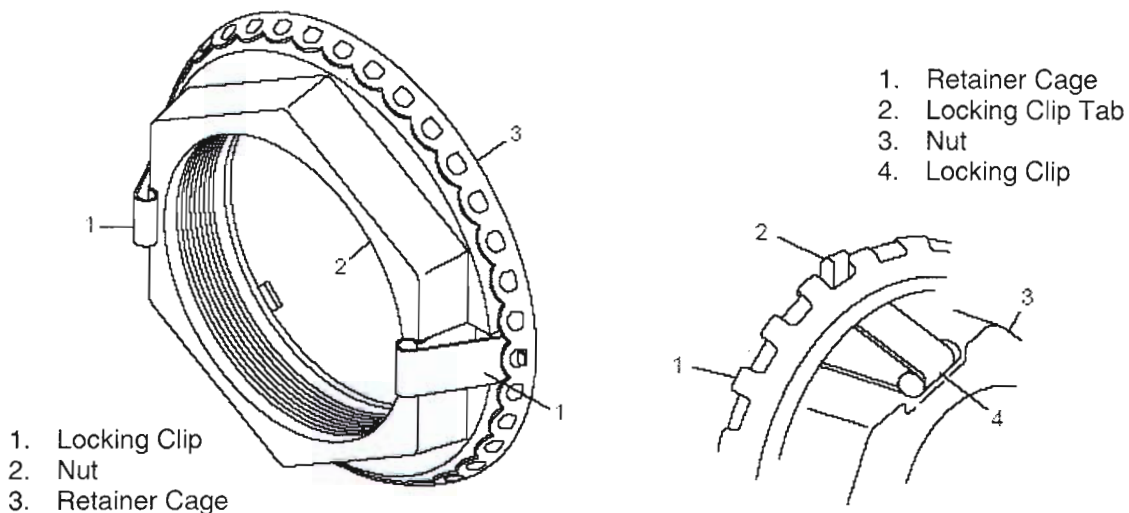
### Axilok Spindle Nut

(c)(5) **Description of the defect:** Improper installation procedures potentially damaged one or both locking clip tabs of the Axilok rear wheel spindle nut. Damage to the locking clip tabs reduces the nut's ability to resist rotation potentially allowing the nut to back off and the dual wheel set to become separated from the vehicle.

**49CFR Section 577.5(f) Evaluation of the risk to motor vehicle safety:** If the rear wheels become separated from the vehicle, the vehicle may become difficult to control leading to a crash without prior warning.

**(c)(6) Chronology of principal events:** On June 19, 2007 the Freightliner's St Thomas truck manufacturing facility identified that Axilok rear wheel spindle nuts were being damaged during the installation process. It was determined that the damage was the result of significant personnel changes at the manufacturing facility on April 2, 2007. Corrective actions were implemented on June 20, 2007.

**(c)(8) Remedial program:** Potentially affected vehicles will be inspected for damage to the Axilok rear wheel spindle nuts. Damaged nuts will be replaced. Repairs will be performed by Freightliner dealerships and Direct Warranty customers, i.e., customers approved by Freightliner to do their own warranty repairs. Estimated dealer notification will be completed by August 15, 2007.
