**Re: Defect Information Report – Supplemental Report No. 3  
07V-343, FL-509, ZF 8018 Steering Gear Spacer**

## Subject: ZF Lenksysteme 8018 Steering Gears

January 2008  
 FL509A-C  
 NHTSA #07V-343

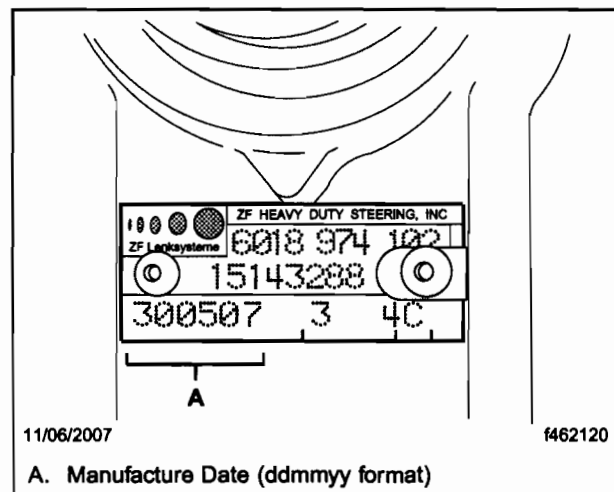
**Fig. 1, Data Plate Identification**

1. Check the base label (Form WAR259) for a completion sticker for FL509 (Form WAR260) indicating this work has been done. The base label is usually located on the front wall under the dash in motorhomes. If a sticker for FL509 is present, nothing further needs to be done. If a sticker is not present, go to the next step.
2. Shut down the engine, set the parking brake, and chock the tires.
3. Check the date code on the data plate of the steering gear. See **Fig. 1**.
  - 3.1 If the date code is 250407 or more, nothing further needs to be done. Go to step 4.
  - 3.2 If the date code is less than 250407 go to "Steering Gear Replacement."
4. Clean a spot on the base label, write the Recall number, FL509, on a blank completion sticker, and attach it to the base label.
5. Remove the chocks from tires.
