General Motors Overseas Distribution Corporation (Singapore)

07V-482
(17 Pages)

Submission of Report 573

J200 IP HARNESS SPLICE PACK (S201) MELTING

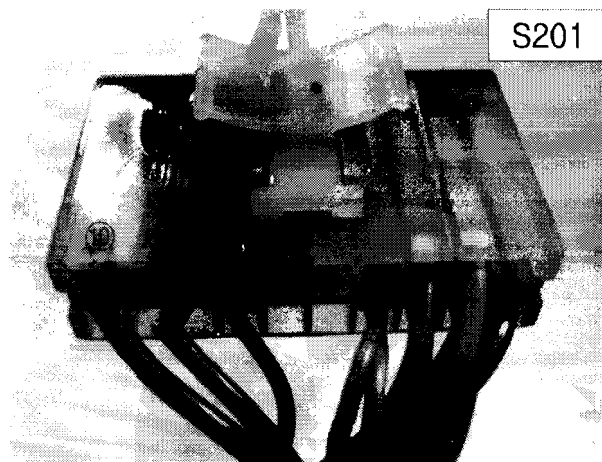
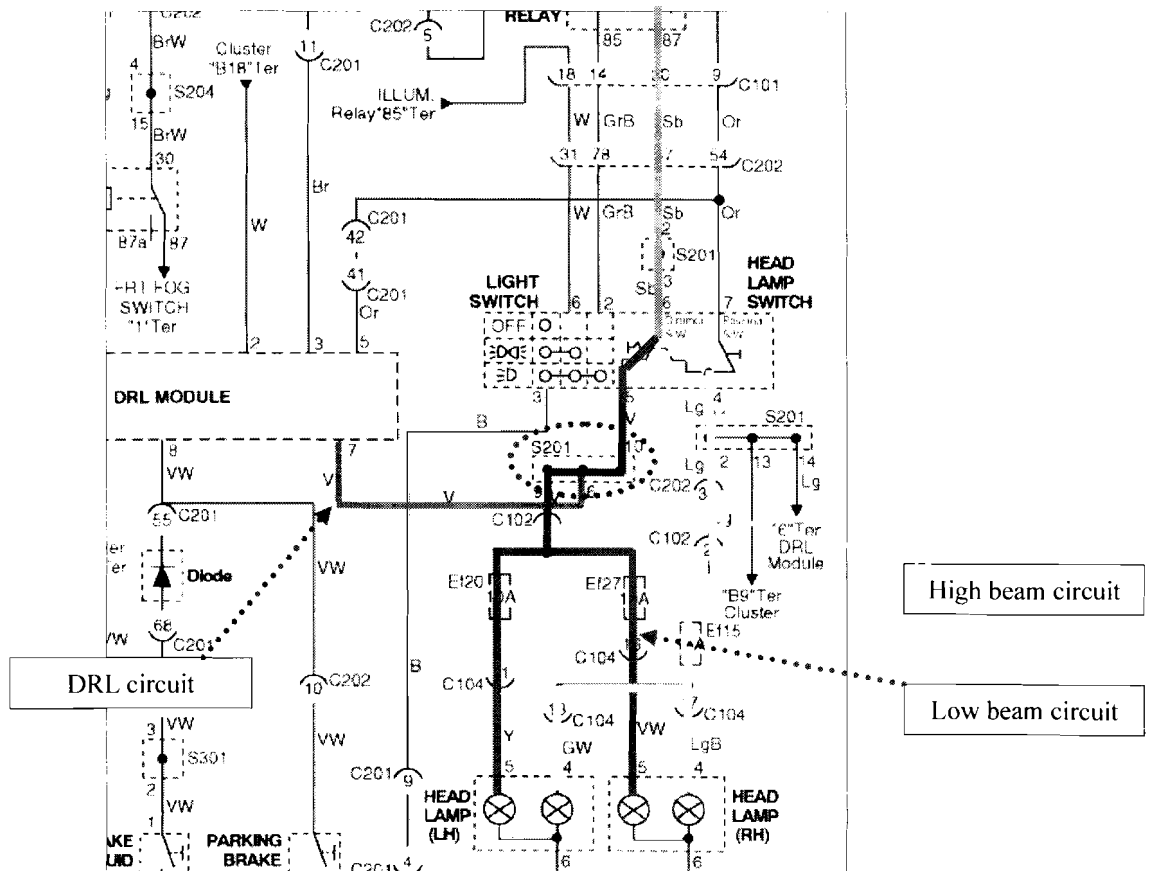
- Head lamp low beam or DRL(Daytime Running Light) function inoperative
 - 2 bulb type Head lamp circuit or DRL installed vehicles occurred on J200 LHD vehicles,
 - IP Harness Splice pack (S201) housing melted.
- ※ U.S.A NHTSA opened PE(Preliminary Evaluation) investigation(Jul.24) and requested IR(Information Request, Due date Sep.19)

- On claimed splice pack, especially 9 pin terminal housing seriously melted and 6,10 pin terminal housing melted due to 9 pin terminal thermal source.
- Female terminal tongue deformed (max 0.78mm, male terminal thickness: 0.6mm)
- On the Terminal Tear down inspection, melted plastic material exist between female & male terminal, resulted H/Lamp inoperative occurred by circuit open.
- Poor contact by undefined factor on terminal causes electric arc and then housing melted.

Head lamp low beam splicing type was changed(Splice Pack → Splice Clip) and separated from Splice pack 201 to protect housing melting due to potential poor contact.
