Re: Safety Defect Report (07V-503 revised)

# Recall Bulletin 71003

**SUBJECT:**  
Relocating  
Electrical  
Components  
And Sealing  
Electrical  
Controls  
Compartment

**ISSUE DATE:**  
December 2007

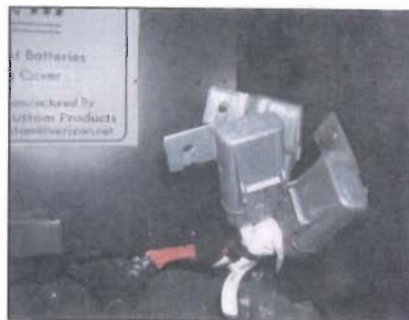
**Figure 3**  
In-line fuses need to be located off the floor of the compartment.

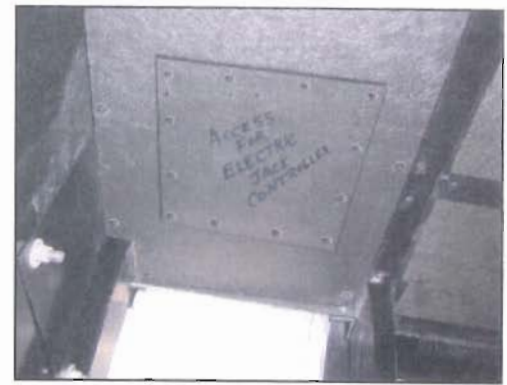
**FIGURE 11**  
Water fill compartment panel  
(shown after installation)

34. Measure and cut a notch in a new 13" x 26 3/4" Polyurethane Panel (Water Fill Compartment Bottom Panel) to fit around the outrigger nearest the entry step. This panel will later be installed parallel with the motor home floor and reach from the bottom flange of the PACO beam to the Inner Skirt Panel installed in Step 30. The panel will also cover the angle steel installed in Step 33, and the bottom of the outrigger nearest the entry step. See Figure 11.
