07V-558  
(7 pages)

070009 INFORMATION REPORT  
(NHTSA RECALL NOTICE \_\_\_\_\_ )

## SAFETY RECALL NOTICE NUMBER 070009 (NHTSA RECALL NOTICE \_\_\_\_\_)

**TZ-34 models: Upper turntable bearing bolt torque procedure.**

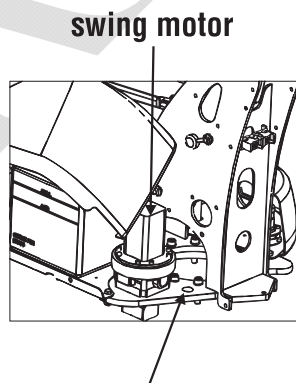
**Illustration 5**

**Lower turntable bearing bolt access hole**
