Re: Defect Information Report FL-519, TRW TAS85 Steering Gear Assembly

Defect Information Report

Re: Defect Information Report

TAS 85 & RCS 85 Steering Gear Issue Summary

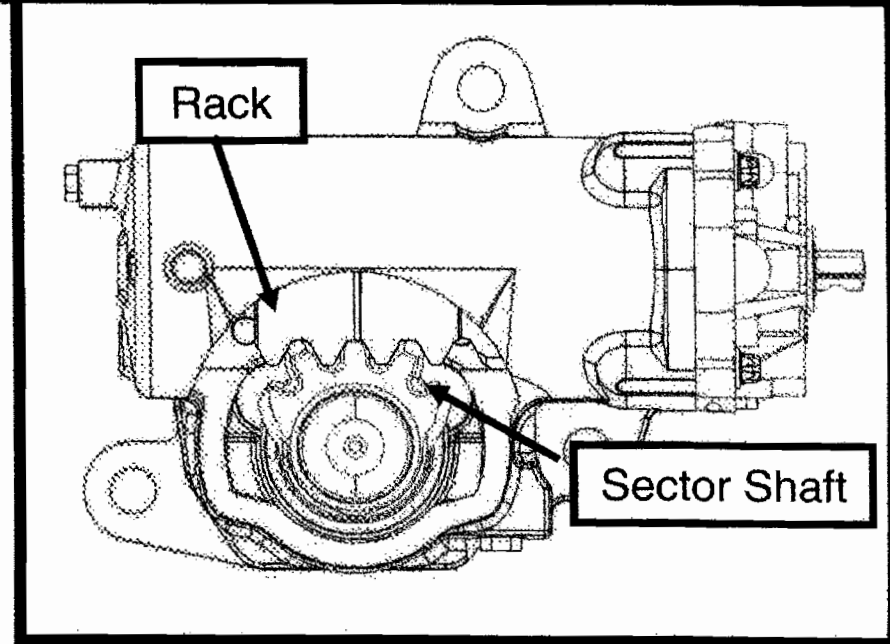
- Suspect parts produced at the Lebanon, TN Plant
- Issue discovered during normal in process testing tear-down audit on Sept 13.
- The sector shaft teeth were machined with an incorrect gear shaper, leaving excess material on face of teeth.
- The excess material causes an interference between the rack teeth involute profile and the sector shaft teeth, leading to a “stick-bind” condition.
- The interference can cause chips of hard material to break off of the sector teeth.
- The chips of material, in some applications, can stay within the tooth system, being crushed by the gear or limiting the gear’s travel

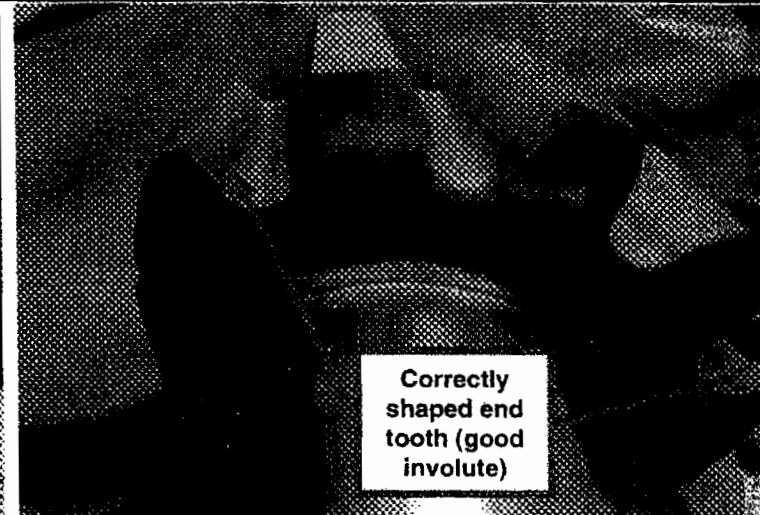
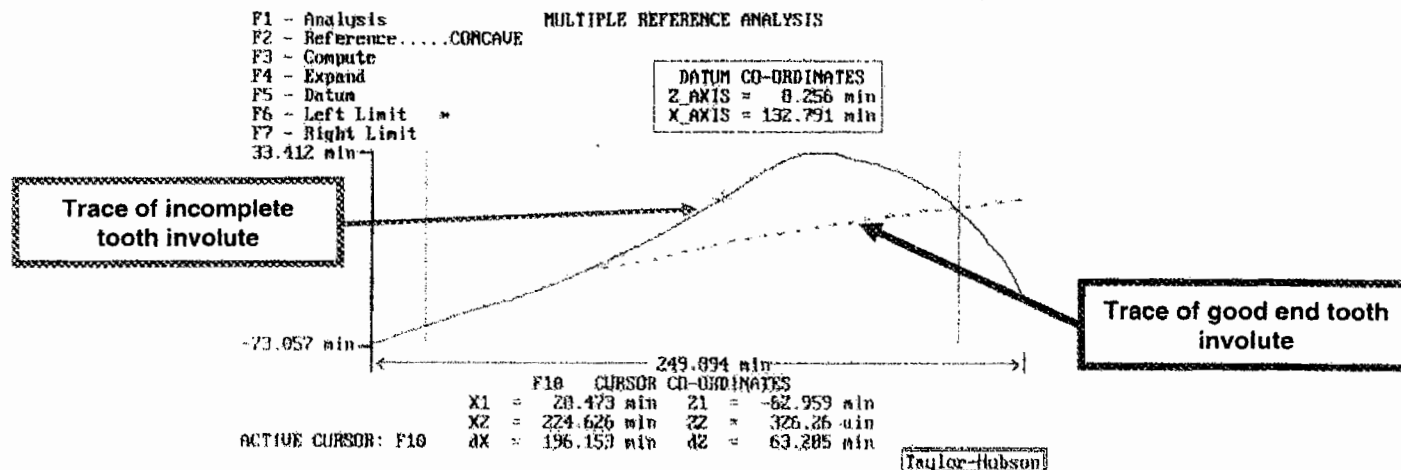
Incorrect Involute Profile on Sector Shaft

The inner surface of the outer sector shaft teeth may have an incorrect gear tooth involute profile. The incorrect gear tooth involute profile was produced with an incorrect gear shaper cutter. The incorrect gear tooth involute profile on the defective sector shafts may interfere with the rack-piston teeth, resulting in a "stick or bind" condition. This condition has the potential to cause the steering gear to stall and restrict the steering turning angle of the vehicle at about 1.25 steering wheel turns into a turn, out of a total available of 2.5 to 3.0 steering wheel turns in either direction.

2.0 Issue Description

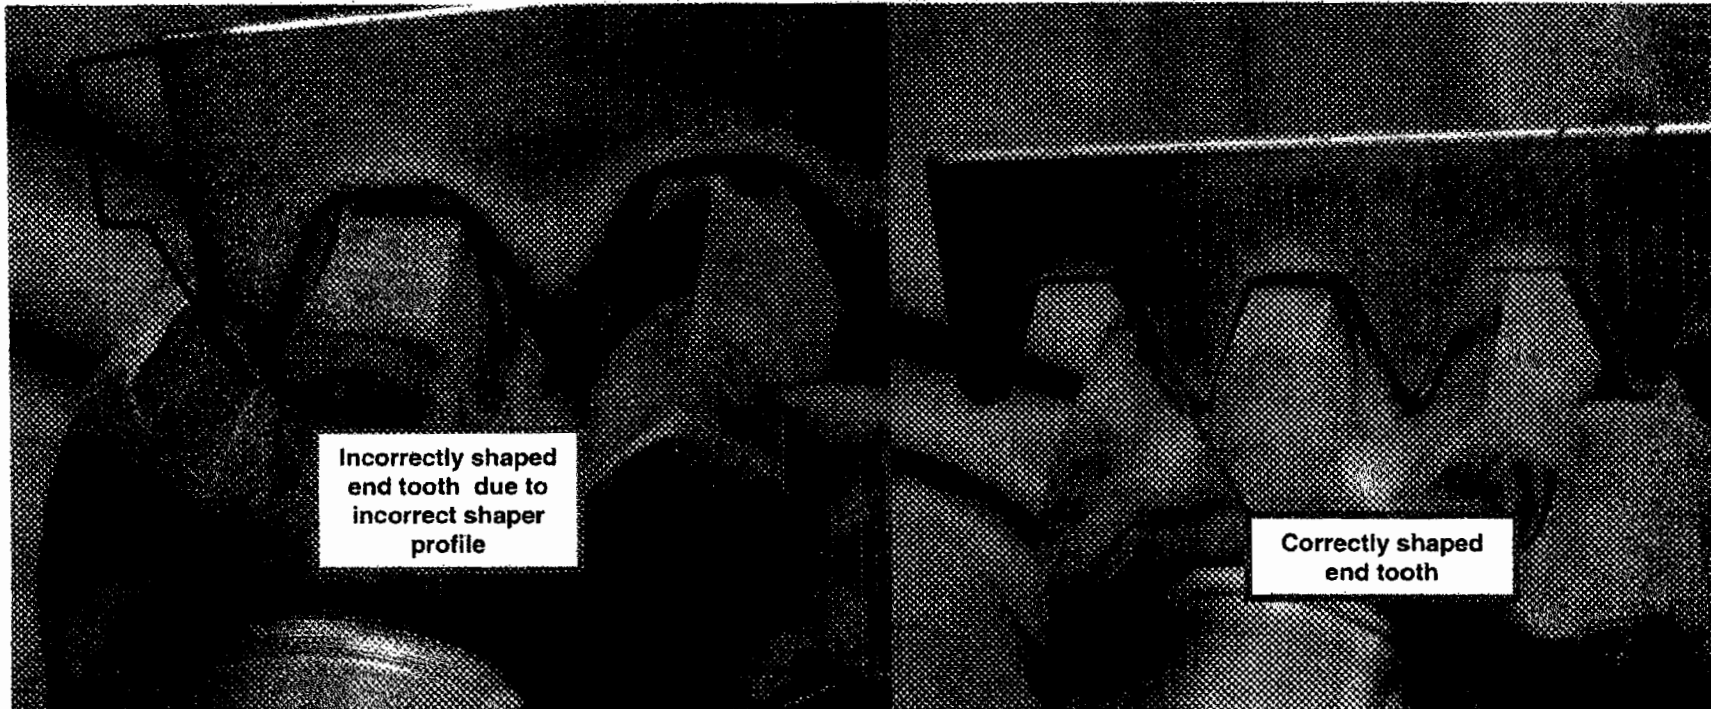
- **Incorrect tool design of shaper**
 - **New 3 Tooth Cutter design had a truncated end tooth shown**
 - **TRW profile gaging method did not identify this condition**

- **Technical reason for issue:**
 - Shaper tooth cutter tool was not designed correctly.
- **Containment**
 - All three tooth cutters Quarantined
 - In-house product locked down on September 13th.

- Measuring system only verified three center teeth. The gaging process should have verified all teeth.
- **Corrective Action Measures**
 - Tooth profile measuring program changed to check all 5 sector shaft teeth vs. middle 3

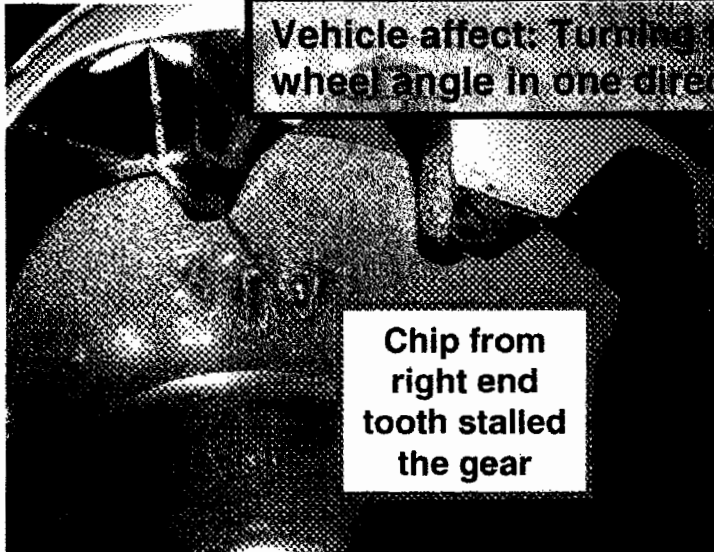
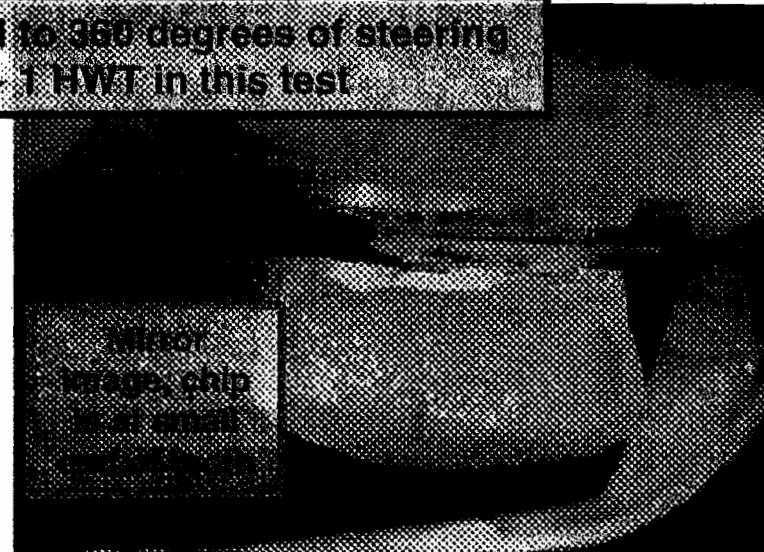
6 30,000 Cycle Wear Tests: 5 complete, one stall

Test Number	Status
8684	Completed 30k Cycles
8700	Completed 30k Cycles
8701	Completed 30k Cycles
8702	Completed 30k Cycles
8703	Completed 30k Cycles
8704	Stalled @ 4,541 Cycles

Stall is defined as the inability of the gear to steer full rated load within prescribed 2,175 PSI pressure rating.

Vehicle affect: Turning limited to 360 degrees of steering wheel angle in one direction ~ 1 HWT in this test

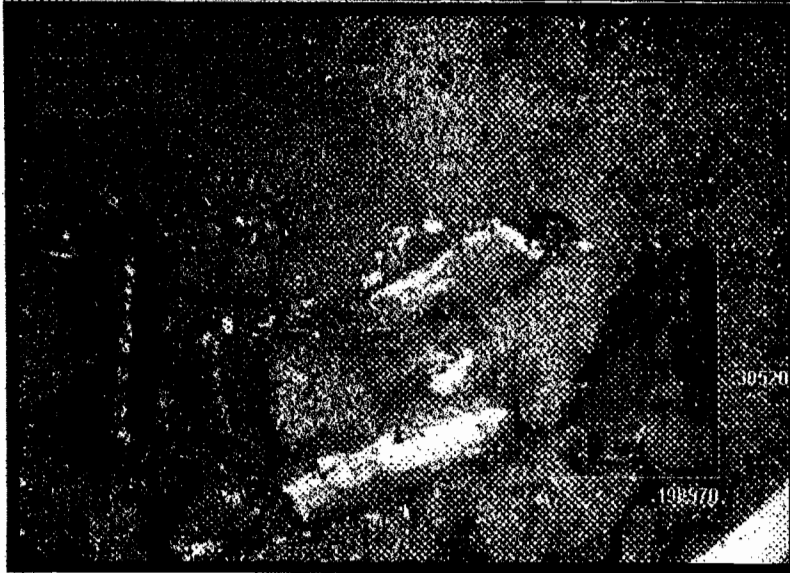
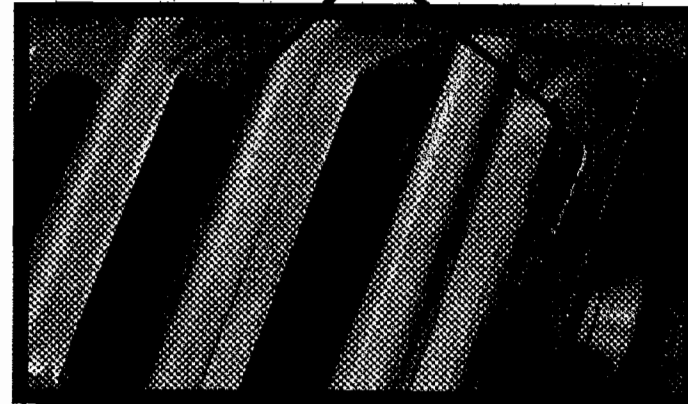
7.2 Contamination & “Chipping”: Full Power Wear Test Generated Damage during Life test

1. All gears had chipping and crushed contamination
2. All gears had tooth and rack wear
3. The test stand stalled preserving the chip, which could be crushed in a controlled test later.

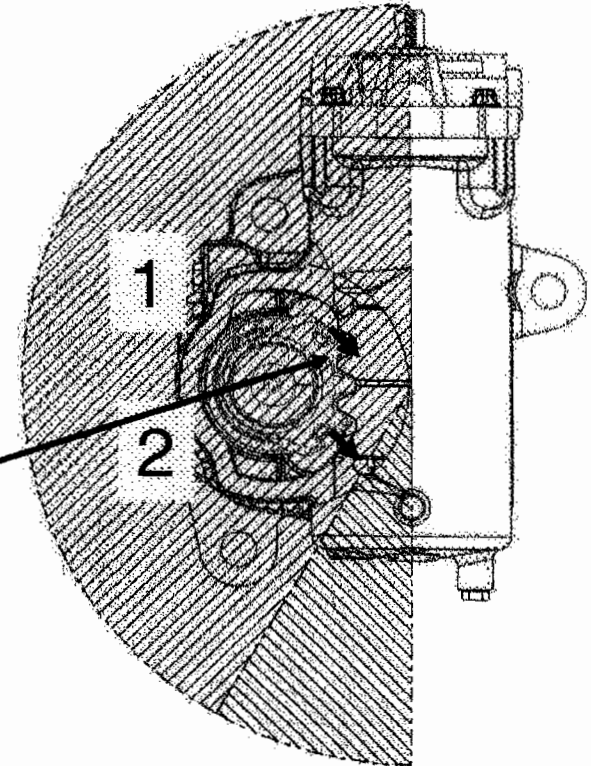
1. 6 steering gears ran to 30,000 cycles (suspend or failure) with the nonconforming “3-Tooth” cutter tooth involute error. 1 Stalled.
2. Gear position was vertical, as shown. Chip migration varies from 1-2, 1 highest risk.
3. Chips are formed, and as they fall into gap, crushing occurs, limiting the risk in the field.
4. 1 of 6 had a “Bind/Stick” stall condition detected by the “shut-down” setting of the test stand. Position 1 confirmed.
5. The stall condition chip was later crushed.

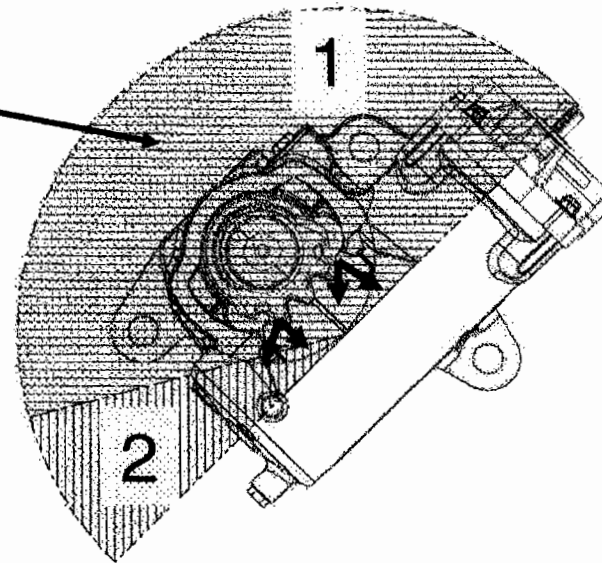
1. Mount inverted @ 60 Degs., as shown which is 54% of suspect population.
2. Six were tested at 1,100 psi load, 2,175 psi stall pump pressure, 750 in-lbs manual torque, 6 more gears.

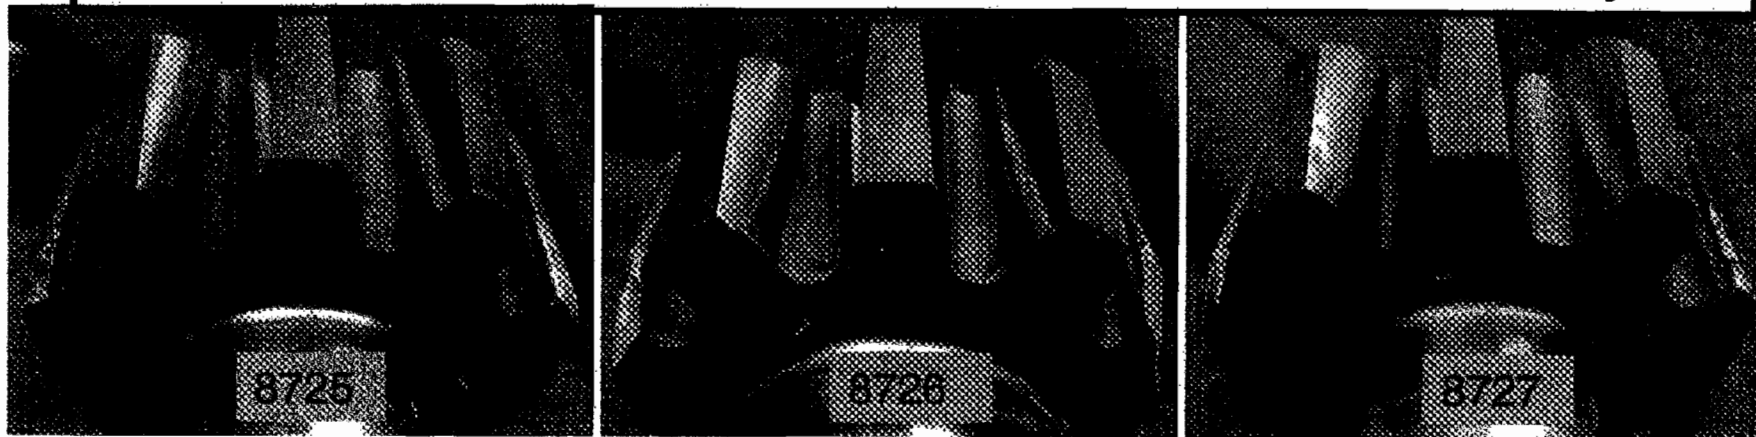
Post test photos: All six gears successfully passed the durability test
