NHTSA SAFETY RECALL

Safety Recall Notice #07E-058 Sissy Bar Remedy

12" and 18" SISSY BARS Recall 07E-XXX

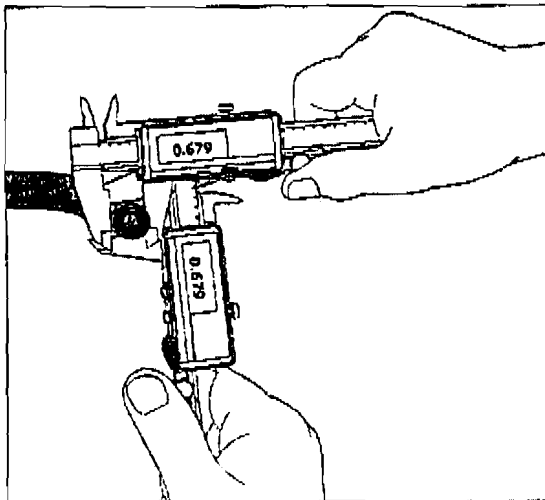
The subject sissy bar assemblies may be undersized, allowing excessive movement of the sissy bar. Over time, this could cause the bolts that retain the sissy bar to break and allow the sissy bar to detach from the motorcycle. This condition could occur without warning and could result in an injury.

SYMPTOM: Mounting screws may break and allow sissy bar to detach from bike.

Typical. Sissy bar measurement locations.

1. Remove the screws and lock washers from both sides of the sissy bar using a 5/16" Allen wrench.
2. Carefully remove the sissy bar from the struts.
3. Measure the sissy bar at both ends, approximately 1/2" from the bottom of the bar. Take two measurements **at each end**, 90° apart. If the bar measures 0.679" or less at any location, replace with either P/N 223-000007-01 (12") or 223-000008-01 (18") as applicable.

4. Install new lock washers and apply Loctite 2440 to the threads of the supplied 3/8" screws. Insert through bottom of fender struts and into the sissy bar. Tighten to 38-40 ft•lbs torque.
5. Return the old sissy bar, washers and screws to Big Dog Motorcycles.
