Ford Motor Company
P. O. Box 1904
Dearborn, Michigan 48121

March 22, 2006

SUBJECT: DEMONSTRATION / DELIVERY HOLD: Safety Recall 07S50:
Certain 2008 F-250/350/450/550 Vehicles Equipped with a 6.4L Diesel Engine
Battery Cable Inspection and Adjustment

CERTAIN 2008 F-250/350/450/550 VEHICLES EQUIPPED WITH A 6.4L DIESEL ENGINE – BATTERY CABLE INSPECTION AND ADJUSTMENT

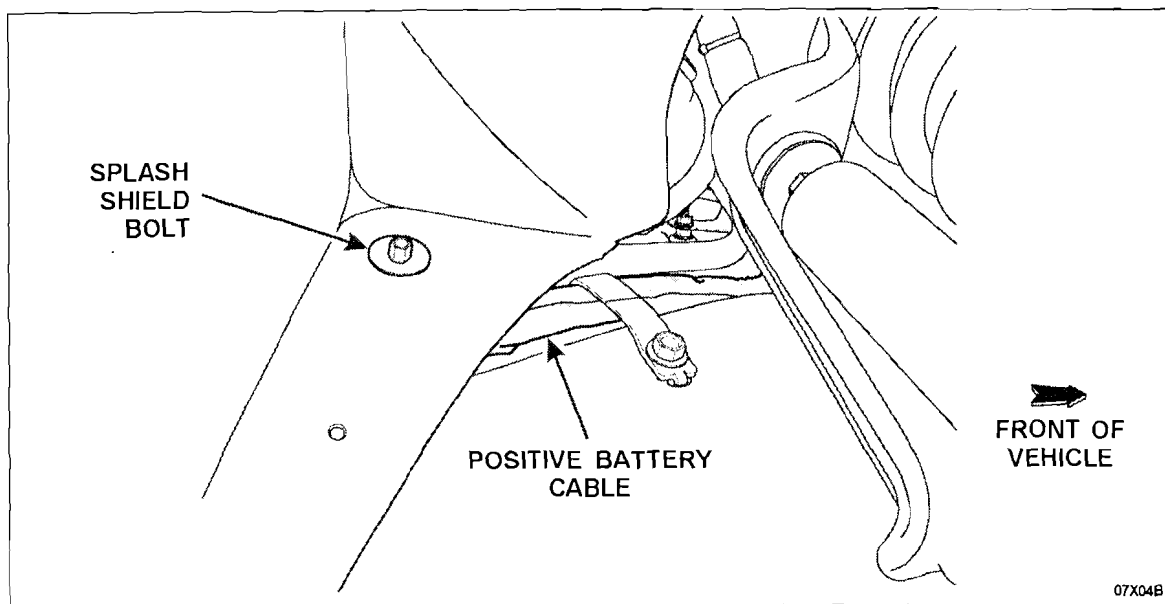
FIGURE 1

1. Place the vehicle on hoist.
2. Verify that there is at least 15 mm (5/8 in) of clearance between the positive battery cable and the splash shield bolt by placing your hand between them. See Figure 1
