SUBJECT: DEMONSTRATION / DELIVERY HOLD: Safety Recall 07S52:

Certain 2007 Explorer and Explorer Sport Trac Vehicles

Steering Gear Assembly Bolt Replacement

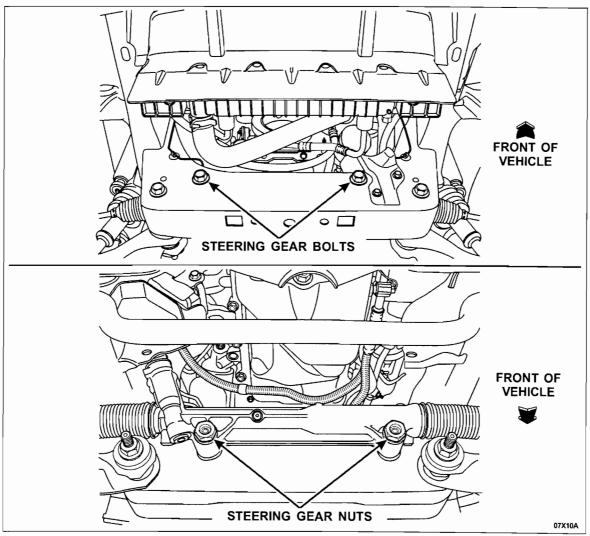
FIGURE 1

In some of the affected vehicles, the bolts that attach the steering gear assembly to the frame cross-member may have been over-torqued. This condition could result in one or both of the bolts fracturing, causing the steering gear assembly to become loose. This condition could cause "clunking" noise when steering as well as decreased steering effectiveness potentially resulting in a crash.

- 1. Raise the vehicle on a hoist.
- 2. Remove the steering gear bolts and nuts. See Figure 1.

- 3. Install new steering gear bolts and nuts.
- 4. Tighten the steering gear bolts to 350 Nm (258 lb-ft).
