SUBJECT: DEMONSTRATION / DELIVERY HOLD: Compliance Recall 07C16:
Certain 2007 Crown Victoria and Grand Marquis Vehicles
Brake Line Inspection

DEMONSTRATION / DELIVERY HOLD: Compliance Recall 07C16

CERTAIN 2007 MODEL YEAR CROWN VICTORIA AND GRAND MARQUIS VEHICLES — ABS BRAKE LINE INSPECTION

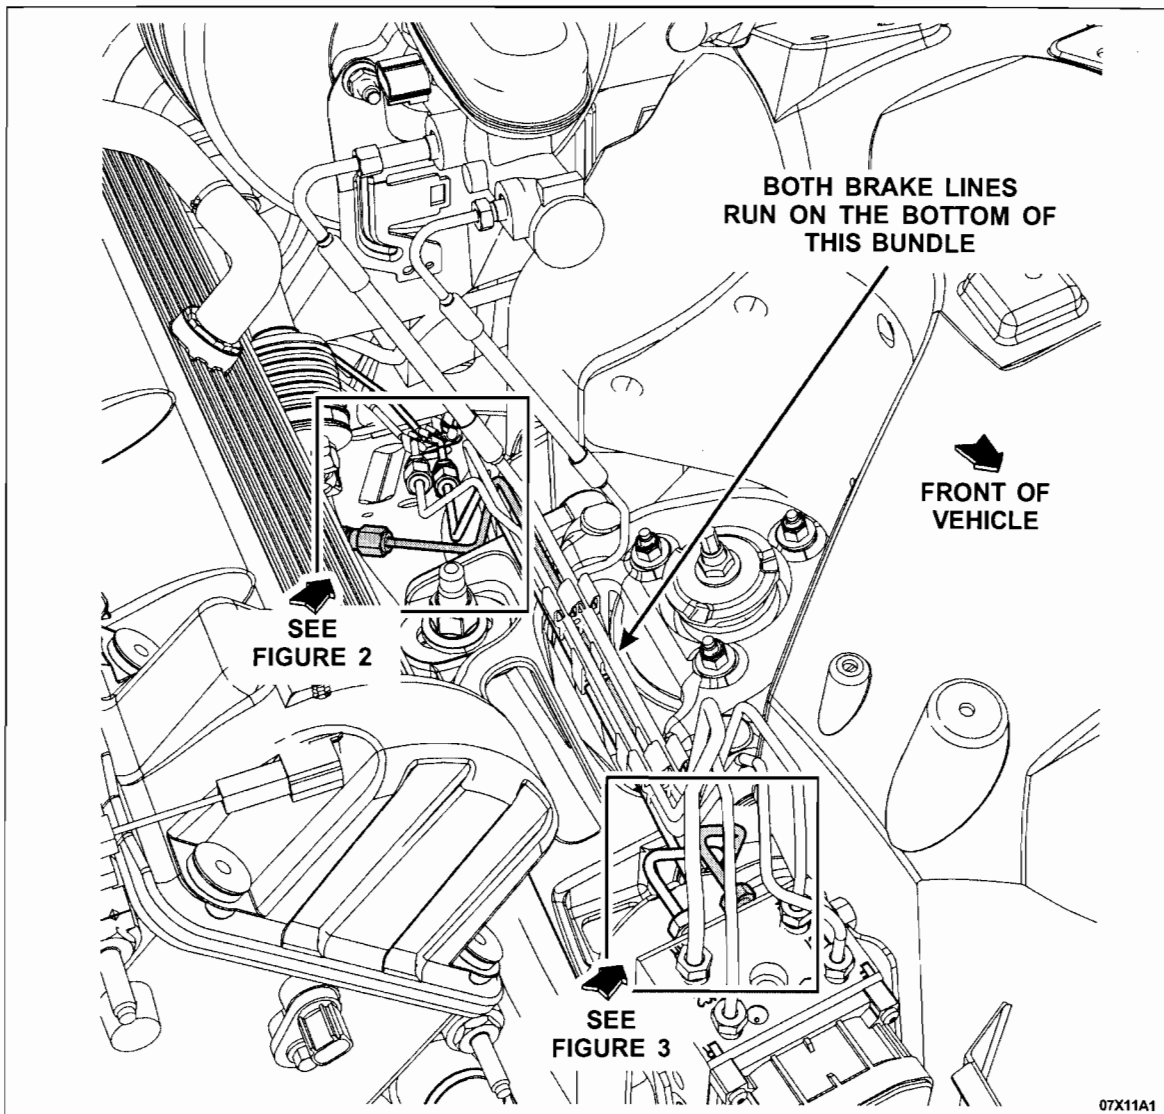
FIGURE 1

This program involves inspecting and, if necessary, repositioning the right side brake lines at the hydraulic control unit (HCU) and bleeding the brake system. Figure 1 shows a routing overview of the right side brake lines.

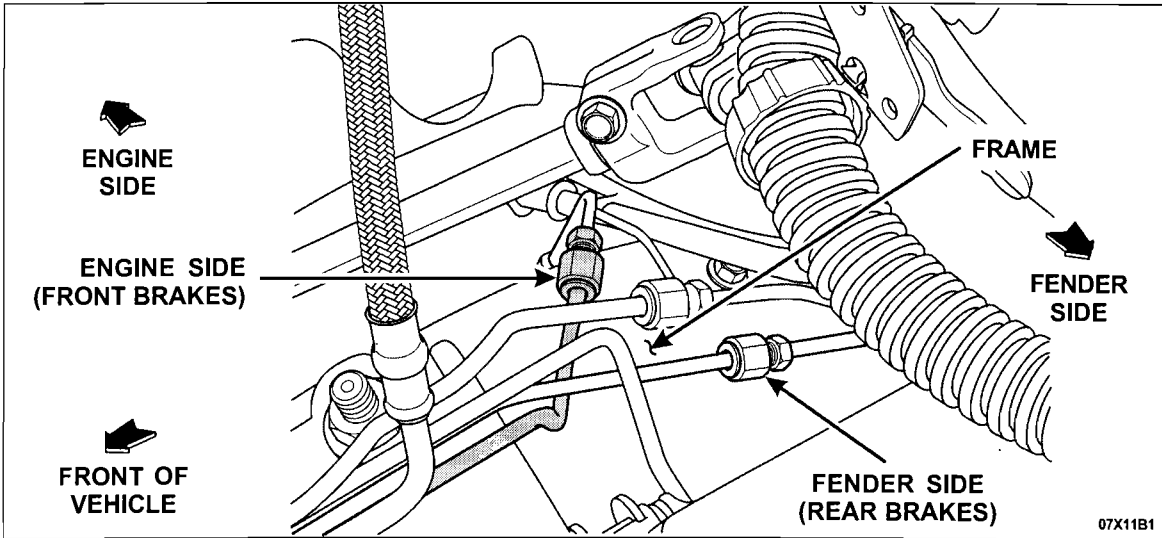
FIGURE 2

Trace the brake line from the Engine Side connection shown in Figure 2 back to the HCU port shown in Figure 3.

- If it traces back to the Fender Side connection of the HCU, the connections are correct. Release the vehicle, no service is necessary.
- If it traces back to the Engine Side connection of the HCU, the connections are **NOT** correct. Perform the Service Procedure in this Attachment III.
