Product Recall

Subject: RECALL 07V-212 – Saf-T-Liner C2 Door Switch

Date: December 10, 2007

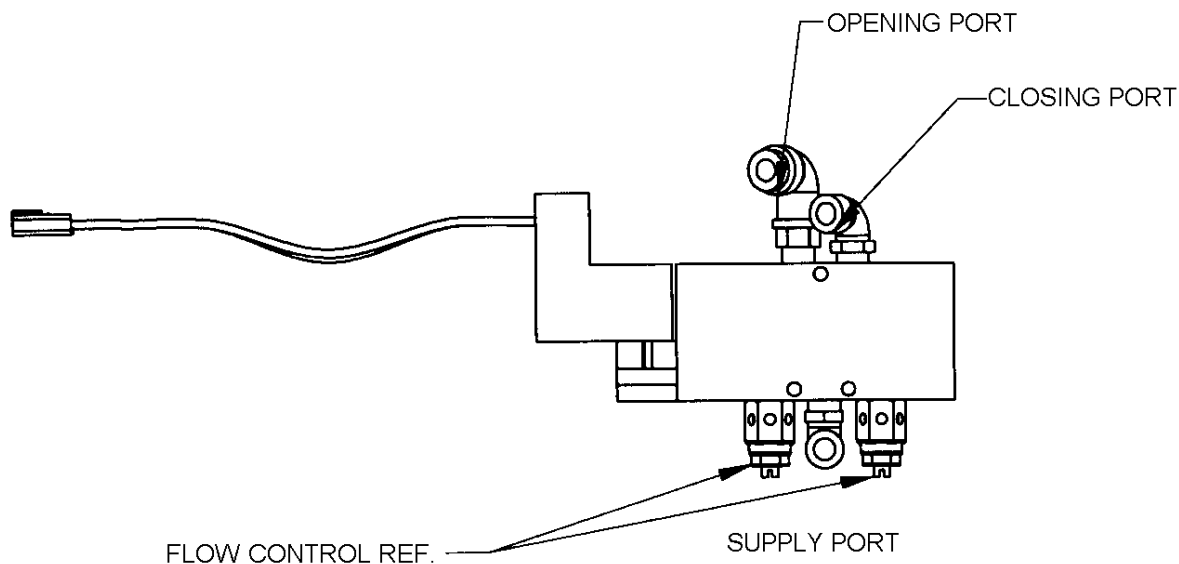
Figure 1

1. **The information in steps 1.1-1.4 is only for doors with the Viking valve. (Figure 1) This valve was used on units with start dates from 2/21/05 through 4/18/06.**

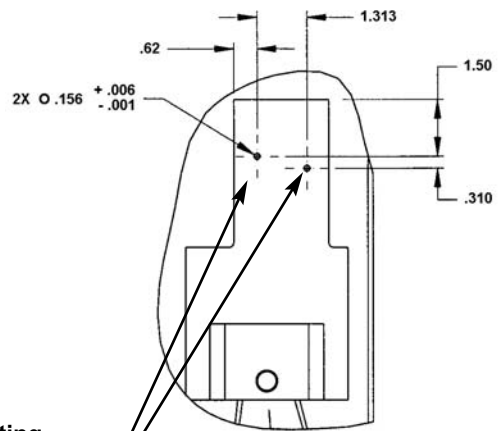
Figure 12

New mounting locations for Solenoid Valve, #TBB 136969.

- 2.5 Re-assemble micro-switch to Filter Bracket, #TBB 116536. **Figure 11**
- 2.6 Attach Inline Air Filter, #TBB 64008902 and #8 Flatwasher, #TBB 69004271, #8 Lockwasher, #TBB 61370346 and Machine Screw, #8-32 x .50, #TBB 61370396. **Figure 11**
- 2.7 After you have removed the valve assembly as shown in **Figure 1**, drill new holes in the mounting plate to accommodate the Parker Valve Assembly, #TBB 136969. **Figure 12**

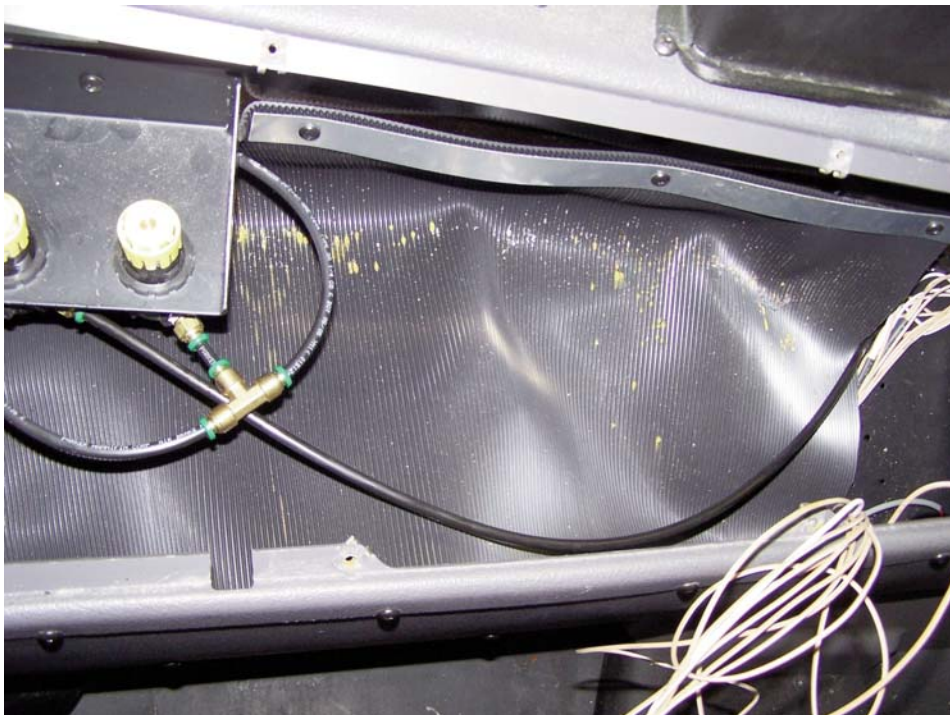
Figure 1

In an effort to help prevent water intrusion in the Switch Hub Module (SHM), the module is being repositioned. This will affect all units from start date of 4/5/04 and until further notice.

1. Disconnect batteries. Apply parking brake and chock tires.
2. Remove the switch panel and disconnect harness from switch hub.
3. Remove the rubber flap shown in **Figure 1**. Retain for reinstallation.
4. Using a 7/16 socket or wrench, remove the three (3) fasteners securing the SHM. **Do not** discard.
5. Making note of the harness connections, then disconnect all connectors in the switch module.

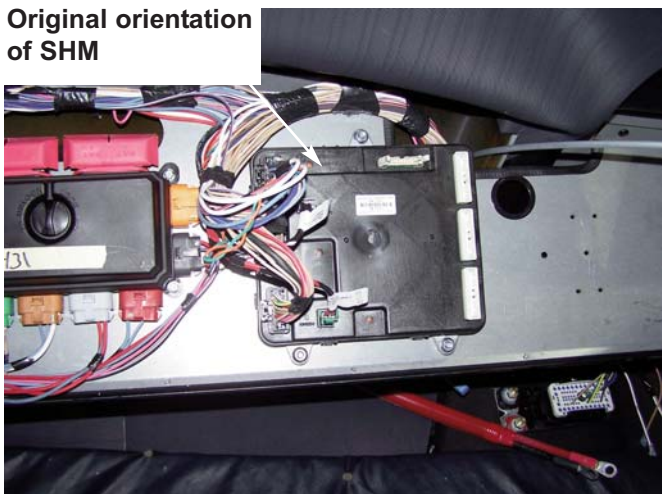
Figure 3

Original orientation
of SHM

7. Reconnect the connectors to the SHM. See **Figure 3** shows the original orientation of the SHM.
8. Rotate module 180°, installing it upside down with connectors face down, using Hex Flange Bolt, #TBB 29890014 and Hex Nut, #TBB 105826. **Figure 4** shows new orientation of SHM.
9. Reinstall the rubber flap which was removed in Step 3.
10. Reinstall switch panel and harness.

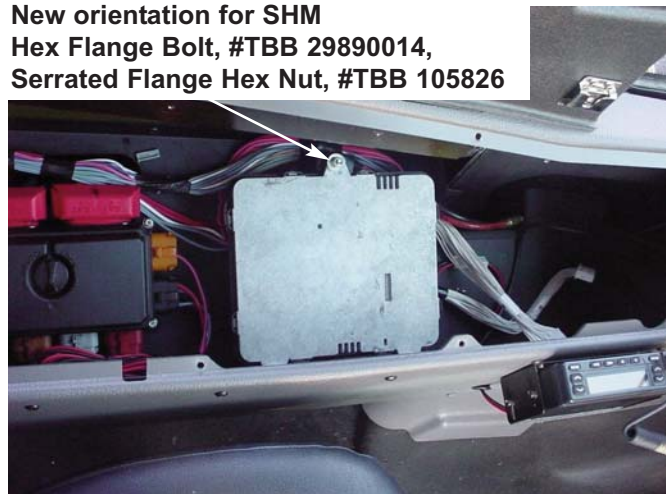
Figure 4

New orientation for SHM
Hex Flange Bolt, #TBB 29890014,
Serrated Flange Hex Nut, #TBB 105826

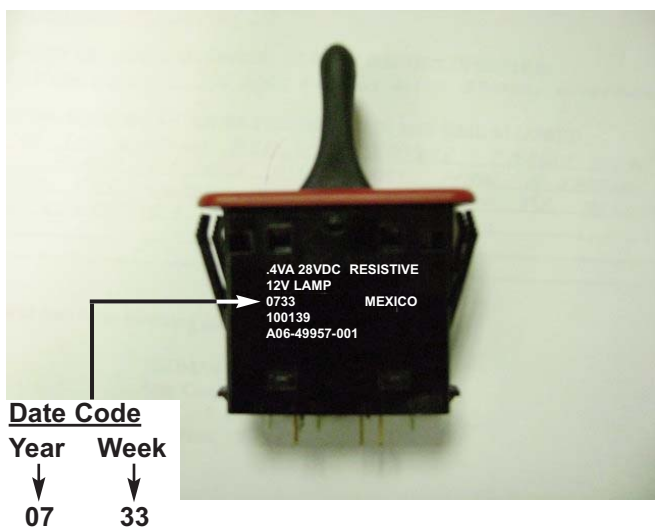
Note: If door switch Date Code is pre-September, 2006 (0636), switch must be replaced. See Figure 7 for an example of switch and location of the date code. Any switch with a Date Code prior to 0636 needs to be replaced, i.e. 0635, 0634, etc. Also, be aware that not all switches have the Date Code printed on the side as shown in Figure 7. Some of the early switches are 'engraved' on the front side (narrow side) of the switch on the "DOOR OPEN" end.

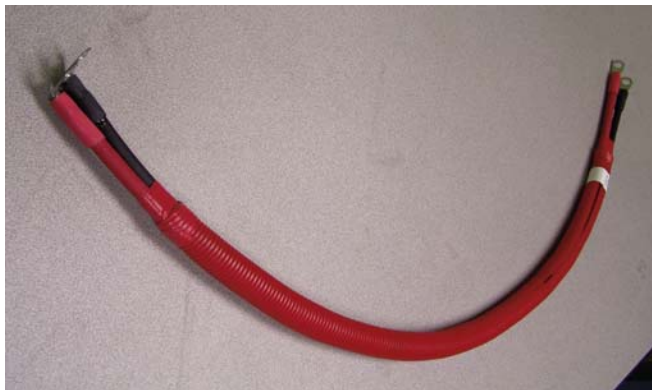
Figure 9

The supply and return cables are currently bundled together. This service bulletin separates the PDM (Power Distribution Module) power and ground cable into independent cables, each covered in convoluted tubing, and separated with standoffs.

6. Remove cable from the vehicle to begin the following modifications. **(Figure 9) Note: Stock cable has the power and ground wire bundled together.**
7. Remove and discard the convoluted tubing from the cable bundle to separate the power and ground cable as shown in **Figure 10**.
