**Re: Defect Information Report – Supplemental Report No. 01  
07V-289, FL-503, DAC Steer Column missing welds**

# Recall Campaign

August 2007  
FL503A  
NHTSA #07V-289

## Subject: Douglas Autotech Steering Column Welds

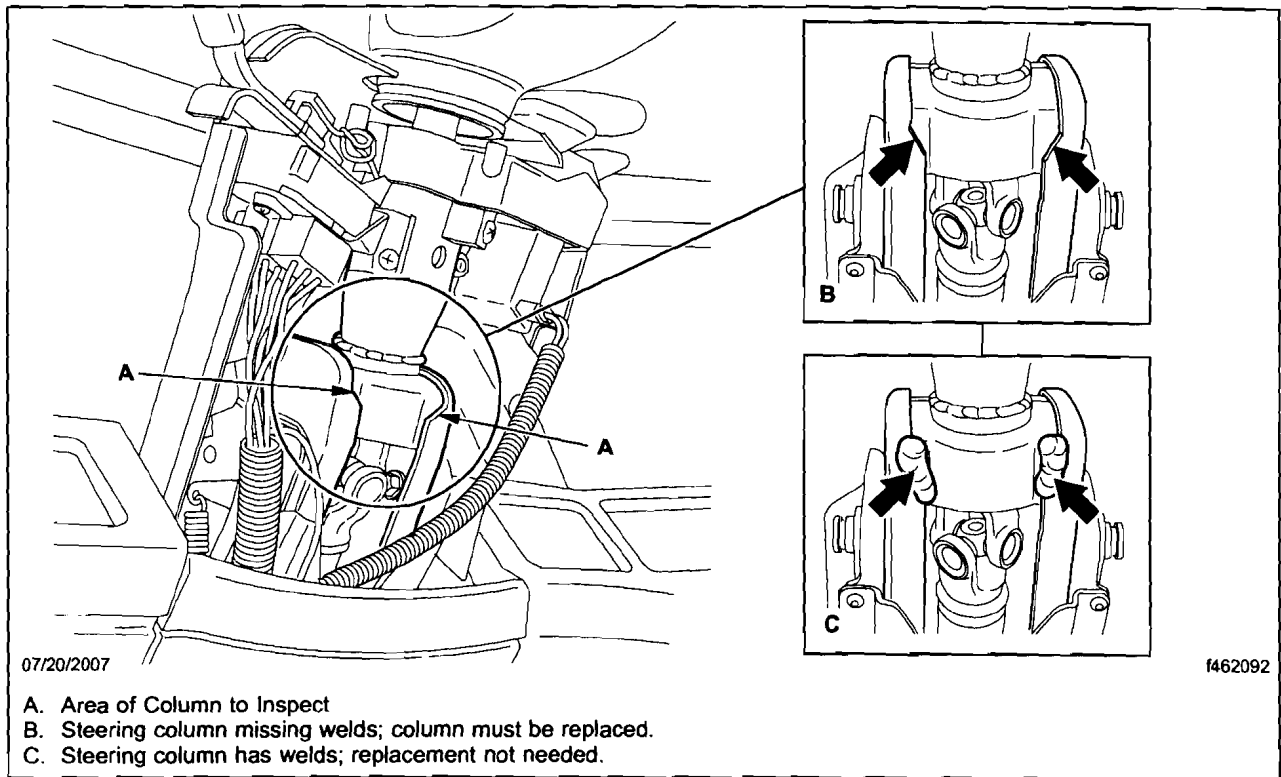
**Fig. 1, Inspection of Column for Welds**

Certain steering columns may have been manufactured without two welds. Columns with missing welds may fatigue and fracture, allowing the steering wheel to progressively move out of its normal operating position, causing a change in steering. If this condition is ignored, a possible vehicle crash may occur.

1. Check the base label (Form WAR259) for a completion sticker for FL503 (Form WAR260) indicating this work has been done. On trucks, the base label is usually located on the passenger-side door about 12 inches (30 cm) below the door latch. On school buses, the base label is usually located over the driver's window. If a completion sticker is present, no further work is needed. If there is no completion sticker, go to the next step.
2. Park the vehicle on a level surface. Shut down the engine, set the parking brake, and chock the tires.
3. Remove the dash knee bolster.
4. Remove the fasteners that hold the back upper steering-column cover to the the steering column, then remove the cover. **Fig. 2**
5. Examine the the column for welds that secure the upper column shaft tube. See **Fig. 1**.

If the welds are missing or cracked, the column needs to be replaced. Contact the Warranty Campaigns Department for authorization. See the instructions in "Steering Column Replacement."

If the welds are OK, clean a spot on the base label (Form WAR259), write the Recall number, FL503, on a blank, red completion sticker (Form WAR260), and attach it to the base label.

1. Take digital photos clearly showing the missing or damaged welds.
2. Submit an inquiry through [www.AccessFreightliner.com](http://www.AccessFreightliner.com) to the Warranty Campaigns Department, including the Recall number, vehicle serial number, and the need to replace a steering column. E-mail your digital photos to: [WarrantyCampaigns@Freightliner.com](mailto:WarrantyCampaigns@Freightliner.com). In the subject line, include the Recall number, inquiry ticket number, and vehicle serial number.
