SAFETY RECALL

SC326

Subject: Steering Shaft Pinch Bolt and Locknut Replacement — GU7 and CHU Models

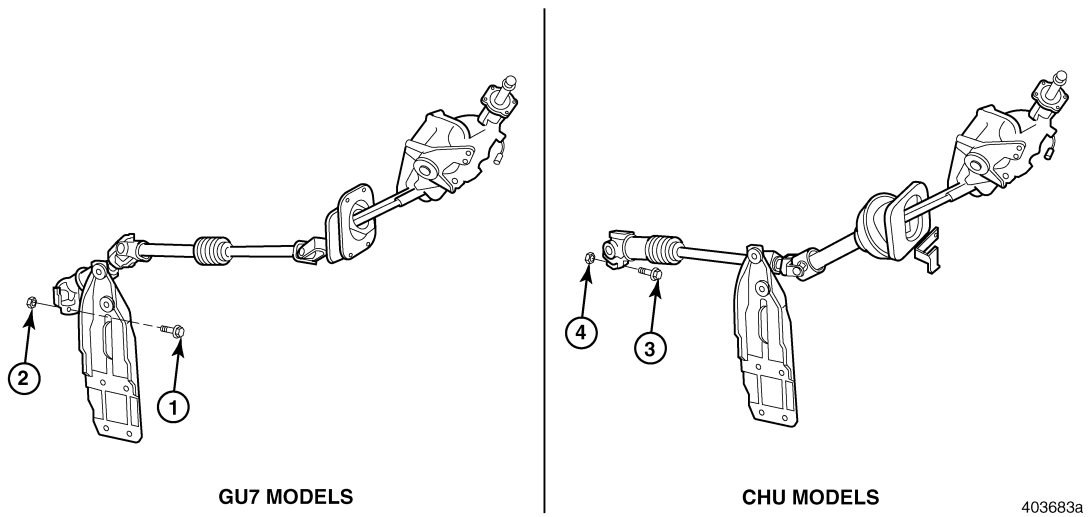
Figure 1 — Steering Shaft Pinch Bolt and Locknut

On certain GU7 and CHU model chassis manufactured between November 14, 2006 and May 22, 2007, it has been determined that the locking feature was omitted during the manufacturing process of the locknut used with the pinch bolt which retains the steering shaft to the steering gear input shaft. Should this nut come loose, the possibility exists for the steering shaft to separate. Approximately 1,072 GU7 and CHU models are affected by this campaign. A list of affected vehicles has been sent to all applicable dealers.

1. Secure the chassis for service, apply the parking brakes and block the wheels to prevent the vehicle from moving.
2. Open the hood.
3. Remove the existing pinch bolt and locknut from the universal joint at the steering shaft-to-steering gear connection (refer to figure 1).

4. Install a new pinch bolt and locknut. Refer to the chart below for the pinch bolt and locknut part numbers.

5. Tighten the pinch bolt locknut proper specifications as follows:
 - 7/16" pinch bolt — 95 N•m (70 lb-ft)
 - M10 pinch bolt — 60 N•m (44 lb-ft)
6. Mark the new nut with a yellow paint stick to signify that the pinch bolt and locknut have been replaced.
7. Return the vehicle to service.
