Service Information Bulletin

Advance Notice of Recall-Check Chain Tensioner (K15)

Recall 07V-367

Model: G 650 X series (K15)

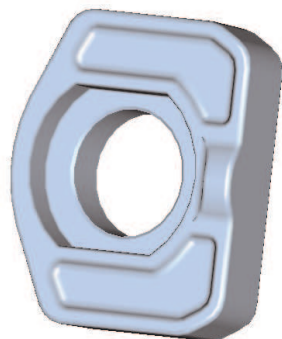
Fig. 1: Left chain tensioner

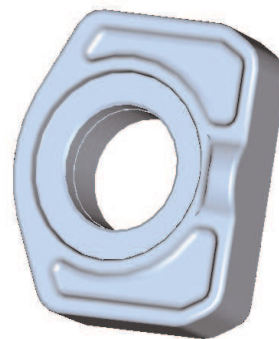
Fig. 2: Right chain tensioner

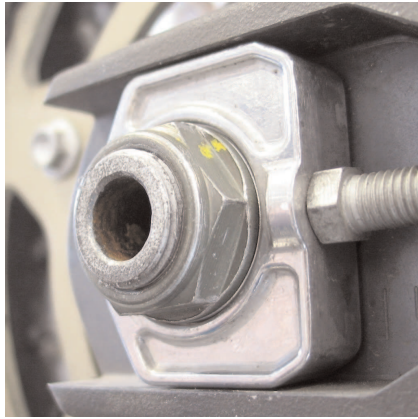
Fig. 3: Correctly installed, right

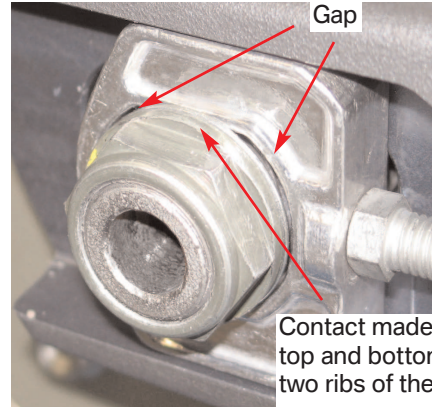
Details: There is a possibility that some motorcycles in the series as stated above might have the wrong chain tensioner installed on one side. We have had reports of motorcycles with the left chain tensioner (see Fig. 1) incorrectly installed on the right-hand side. If the wrong chain tensioner is installed, the hex nut is seated against only two ribs of the chain tensioner (see Fig. 4). Under these circumstances a gap is visible between the washer and the recess in the chain tensioner.

Fig. 4: Incorrectly installed, right

Aftersales Solution: In order to determine if a specific motorcycle is affected by this Technical Campaign, it will be necessary to verify all motorcycle VINs through a DCS Vehicle History Check. Based on the response of the system, either proceed with the repair or take no further action. If the wrong chain tensioner is installed, it must be removed and the correct chain tensioner installed in its place. Please note that if the hex nut and/or washer show signs of damage these parts have to be replaced as well. Installation of the washer (36 31 7 708 007) is not documented in the Repair Manual (RepROM). It is essential to install the washer. The appropriate passage in the repair manual will be corrected in the next issue (RSD 09/2007).
