SI B34 02 07
Brakes

September 2007
Technical Service

Recall Campaign 07V-391: Inspect the Brake Fluid Reservoir Cap

E70 (X5)

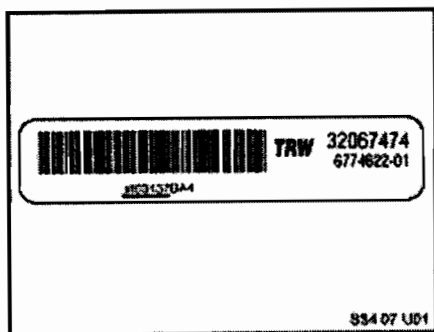
The cap for the brake fluid reservoir incorporates a fluid level switch. The switch is used to monitor the level of brake fluid in the reservoir. When the fluid falls below the minimum level, the switch triggers a warning lamp in the instrument cluster. Due to a manufacturing fault within the switch, the switch may fail to trigger the warning light.

Remove the left microfilter housing cover, refer to Repair Instruction RA 64 31 101. Locate the label fitted on the brake booster. The serial number is located on the label below the bar code. Compare the serial number on the brake booster with the list attached to this bulletin. Only the first seven digits of the serial number are necessary to identify the affected components. If the serial number is contained in one of the ranges on the list, replace the cap for the brake fluid reservoir. If the serial number is not contained within the attached list, the cap does not require replacement. Reinstall the microfilter housing cover.
