SERVICE ADVISORY # 07-095

Hideout/Energy Hanger and Shackle Bolt Torque

2008 Hideout and Energy Travel Trailers Manufactured in Pendleton, Oregon

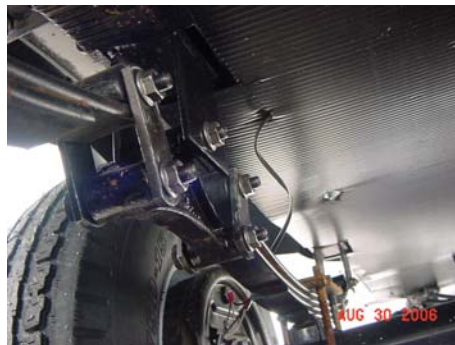
Keystone is conducting a voluntary RECALL notification campaign in accordance with the National Highway Transportation and Safety Act. The above 2008 Hideout and Energy Trailers may have been manufactured with the incorrect hanger & shackle bolt torque. The following procedure describes how to perform the repairs required.

- Step 1 Locate the trailer on a level flat hard surface. Chock the wheels.
- Step 2 Visually inspect and verify that lock nuts are attached to all hangers and shackles.

- Step 3 If all bolt and nut assemblies are present proceed to next page for torque instructions.
- Step 4 If any of the bolt and nut assemblies exhibit damage, order the required number of parts listed above.
- Step 5 Once the parts arrive, proceed to **HANGER / SHACKLE TORQUE INSTRUCTIONS w/ REPLACEMENT PARTS** on the next page.

Step 1 Place the box end wrench on the bolt head and the torque wrench on the nut, Torque all hanger and shackle nuts to 30 – 50 ft.-lbs. Note – be sure shoulder portion of the bolt is installed correctly through the shackle links and spring hangers so the suspension parts can rotate freely.
