December 04, 2007

SUBJECT: Safety Recall 07S57:
Certain 1997 - 2003 F-Super Duty, Excursion, and E-Series Vehicles
Equipped with 7.3L Diesel Engines
Camshaft Position (CMP) Sensor Inspection / Replacement

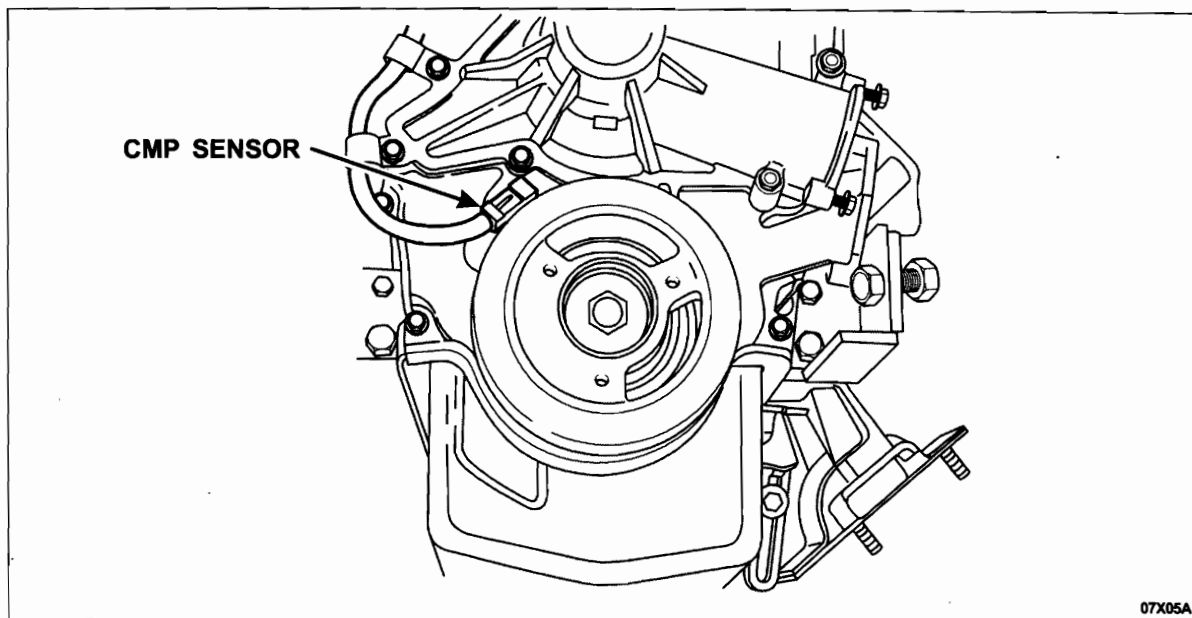
FIGURE 1

1. With the vehicle in NEUTRAL, position it on a hoist.
2. Inspect the color of the CMP sensor and bracket assembly. See Figure 1 for location of the CMP sensor.
 - ***If the CMP sensor is gray with a silver bracket, no action is required.***
 - ***If the CMP sensor is black with a gold bracket, proceed to the Service Procedure.***

1. Disconnect the wiring harness connector at the CMP sensor.
2. Remove the retaining bolt and the CMP sensor and bracket assembly.
3. Install a **new** CMP sensor and bracket assembly and retaining bolt. Tighten the retaining bolt to 24 Nm (18 lb-ft).
4. Connect the wiring harness connector to the CMP sensor.
