**SUBJECT: MCI F3500 STEERING ARM IDLER BRACKET RECALL**

Ref.: NHTSA # 07V-191  
TRANSPORT CANADA # 07-146  
MCI Service Bulletin 279C

# Service Bulletin No. 279C

MODEL F3500 Series Coaches	TYPE Field Change Program	SECTION/GROUP 11-Steering	DATE Aug. 7, 2007
SUBJECT STEERING ARM IDLER BRACKET			
CONDITIONS

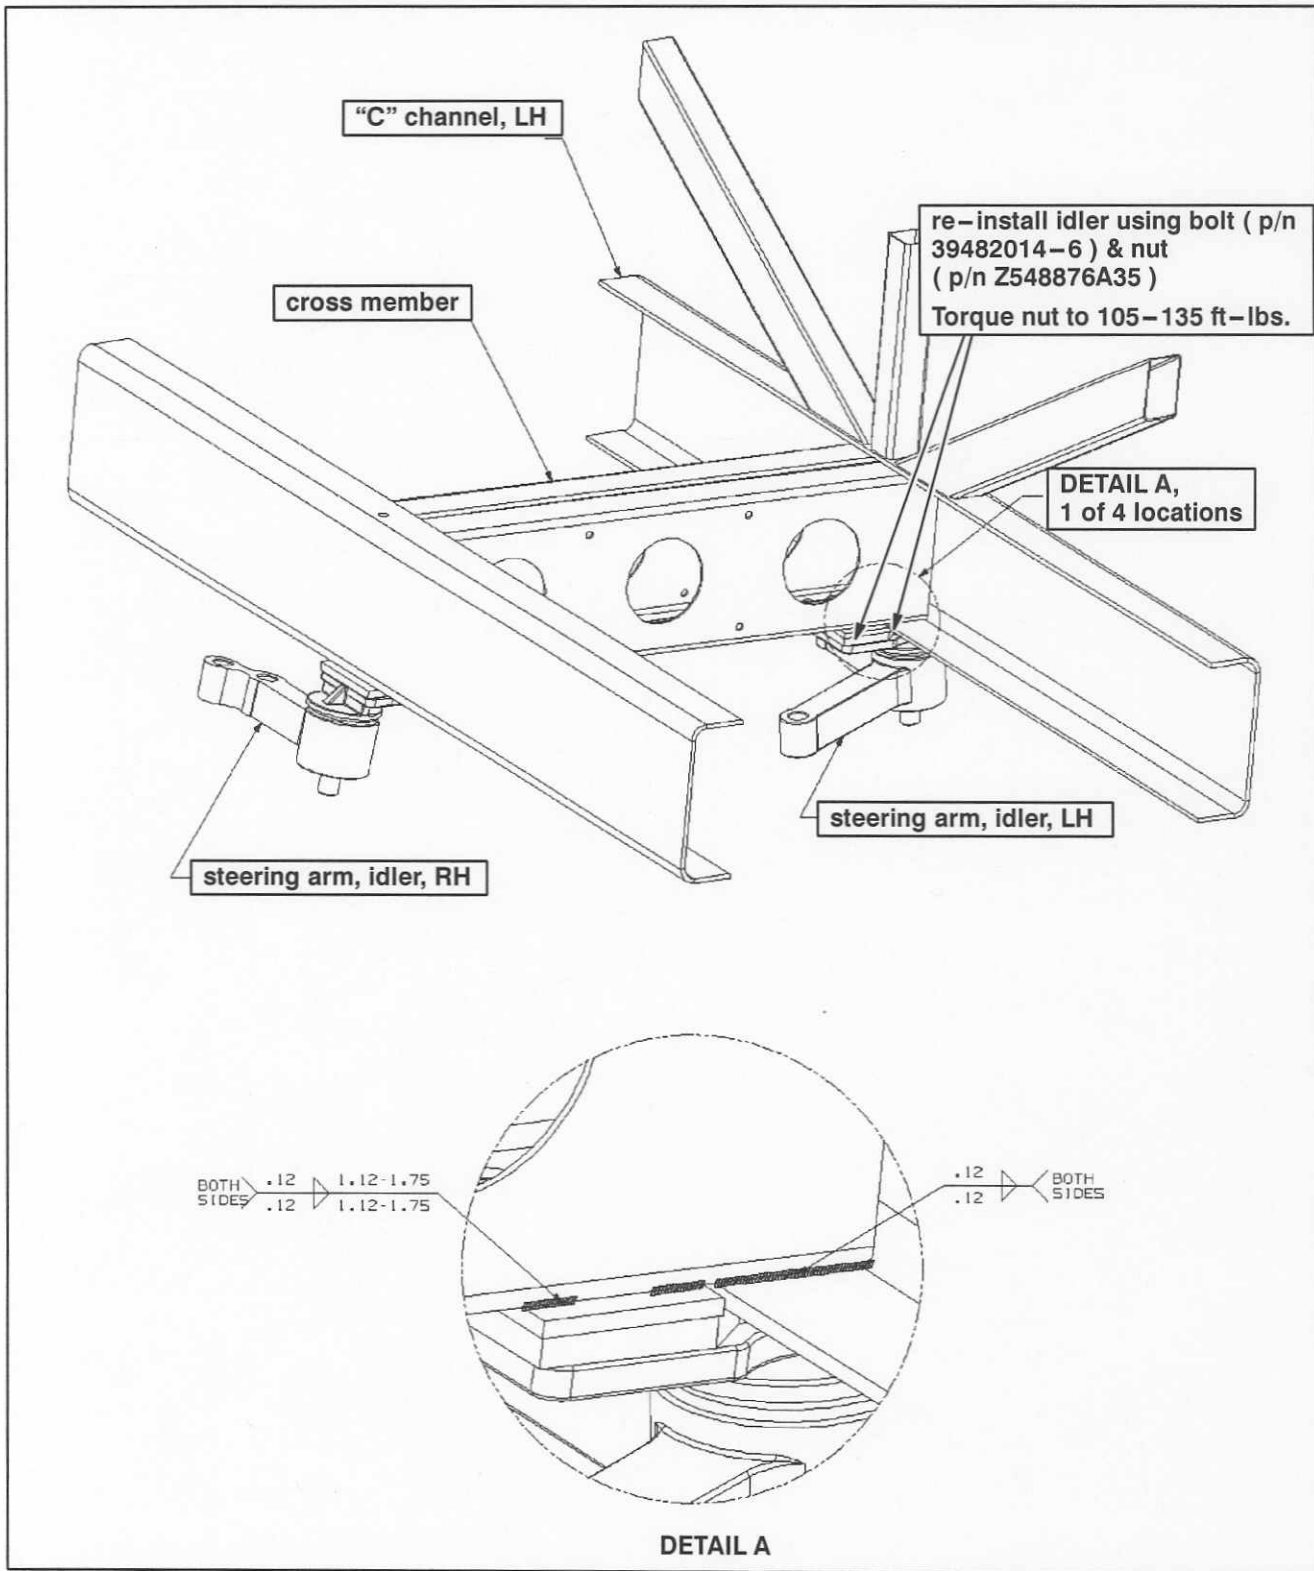
Customer can experience cracking, originating at the heat-affected zone of the weld at the steering arm idler bracket location.

MCI determined that the cracking had originated at the heat-affected zone of the weld at the steering arm idler bracket location, apparently as a result of insufficient welding process during manufacture. If not identified and repaired during regular maintenance and inspection, the cracking could allow movement of the idler plate, and over an extended period of time progress and result in reduced steering control or steering loss if total failure of the mounting occurred.

6. Inspect the four weld areas shown in Figure 2 / Detail A and the two weld areas shown in Figure 3 / Detail B.
7. If a crack is present, at the location shown in Figures 2 and 3:

Figure 2. Top view of front bogie. Inspection required of four locations.

5. Using an industrial heat gun and steel brush, clean the four weld areas shown in Detail A and the two weld areas shown in Figure 3 / Detail B.

- a. drill a 1/8 inch hole at the extreme end of the crack,
  - b. bevel both sides of the crack to create a V groove,
  - c. run a continuous weld, ensuring full penetration,

- d. grind the weld flush with the face of the plate.
8. Locate the existing suspension plate shown in Figure 4 / Detail A. Remove and discard the existing suspension plate and mounting hardware. Install the new suspension plate ( p/n 12-01-1252 ) using the mounting hardware provided ( p/n 19-1-994, 19-02-0383 and 19-03-0582 ). Hand-tighten and snug the nut's. Repeat to the opposite side. Weld the suspension plates, using the weld size and location in Figure 4 / Detail A.

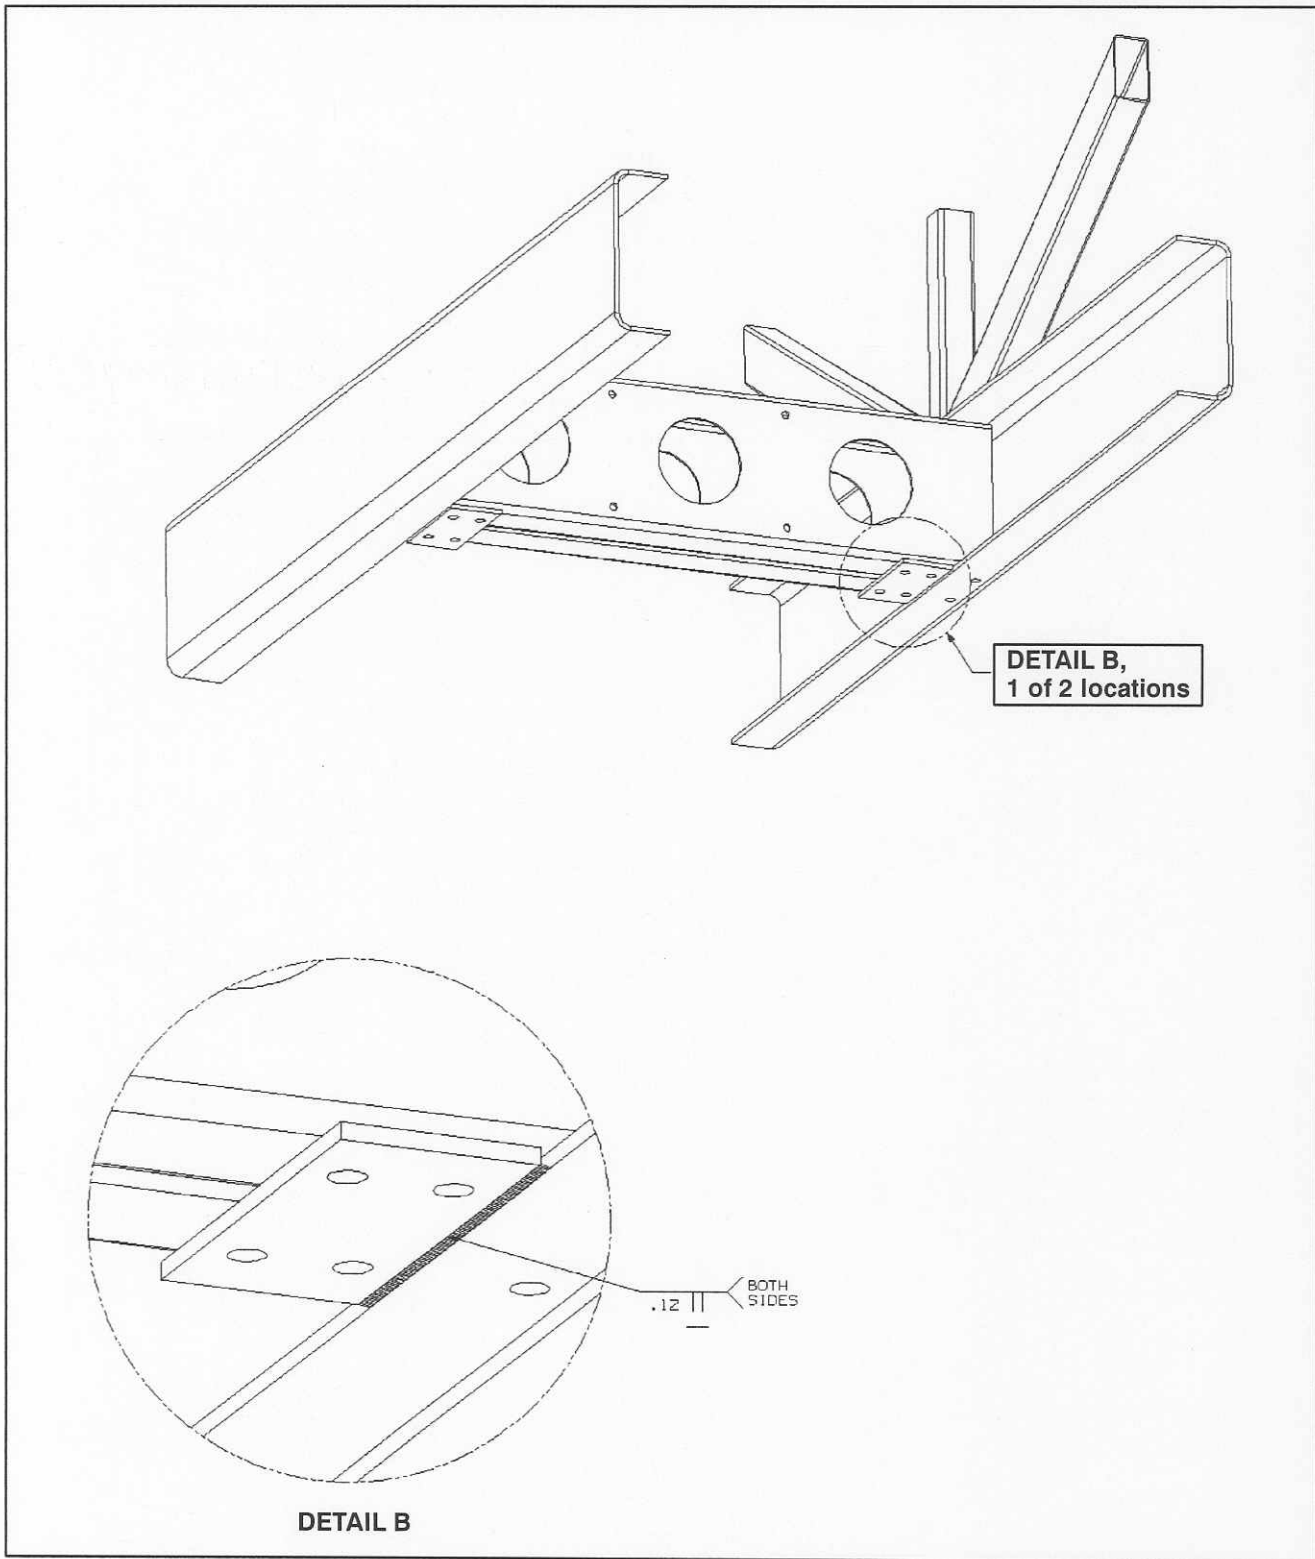
Figure 3. Bottom view of front bogie. Inspection required of two locations.
