Ref: NHTSA Campaign Number 07V-231

Recall 07V-231

## PROCEDURE FOR IDENTIFYING AND REPLACING SEAT BELT TETHER

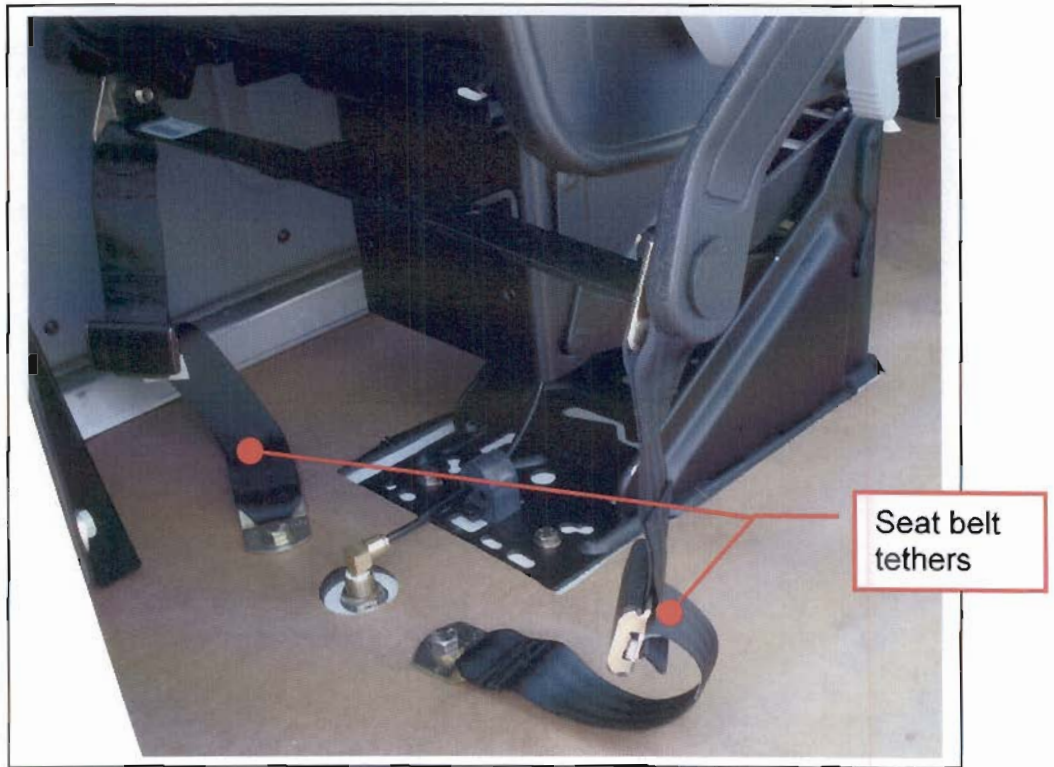
Figure 1

1. Locate the tethers on both sides of the seat. The tethers are the portions of the seat belt that are attached to the seat frame and the floor of the cab. See figure 1.

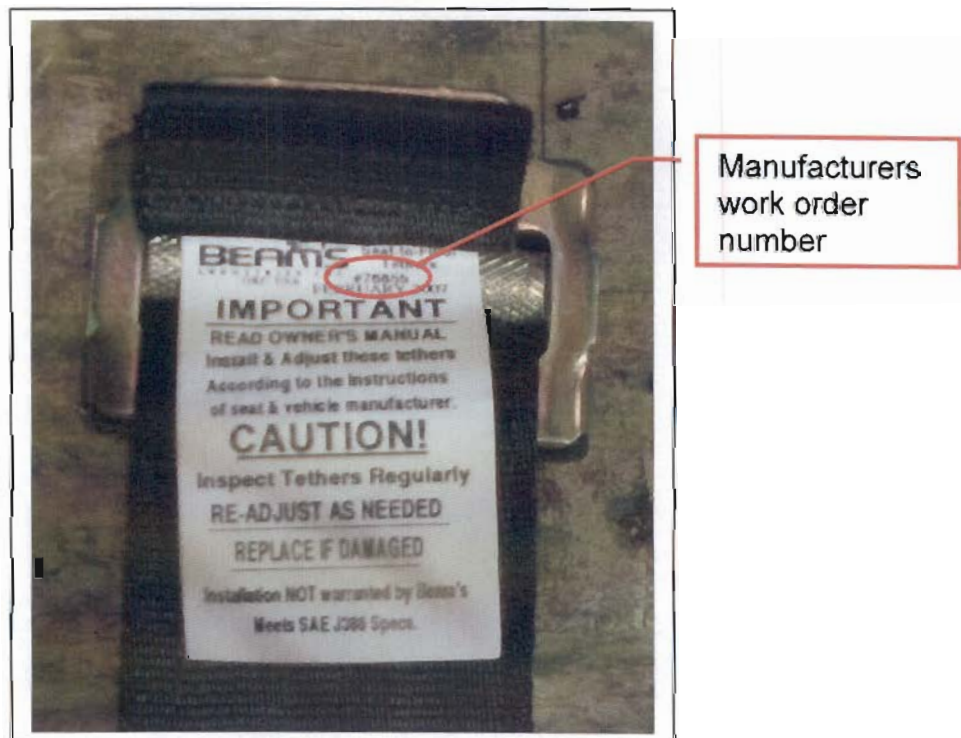
Figure 2

2. Turn the tether until the identification tag is legible.
3. Locate the manufacturer's work order number on the identification tag. See figure 2. If the number is 79361, then contact Kalmar Customer Service for replacement parts kit part number 53575634 and continue to steps 4 thru 7. If the number is **NOT** 79361, then replacement is not necessary.
