Subject: Front Wheel Bearings and Hub Lubrication

Recall Campaign

July 2007
FL500A
NHTSA #07V-266

Work Instructions

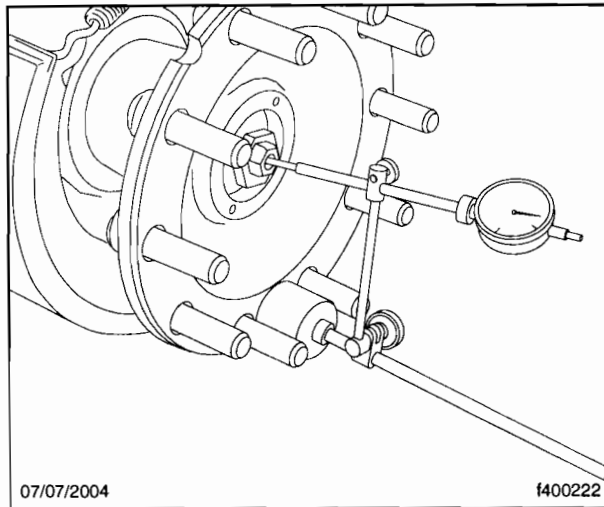
Fig. 2, Using the Dial Indicator

IMPORTANT: The end play must be between 0.001 and 0.005 inch (0.025 and 0.127 mm). *Use the dial indicator to measure this.* Correct end play is crucial to the life of the wheel bearings.

- 23.5 With the jam nut installed and tightened, *attach a dial indicator to the hub* and set the point of the indicator in line with the end of the axle spindle. See **Fig. 2**.
- 23.6 If the brakes were used to hold the drum during installation, release them.

If the end play is not within the correct range, remove the jam nut and locking device and back off or tighten the inner (adjusting) nut to adjust the end play.
