SUBJECT: NHTSA Recall No. 07V-272

Inspection Procedure for 14 x 14 x 84 and 14 x 14 x 96 Manifolded Tanks
May 9, 2007

INSPECTION PROCEDURES FOR 14 X 14 X 84 AND 14 X 14 X 96
MOUNTED - MANIFOLDED MOTOR FUEL CYLINDERS

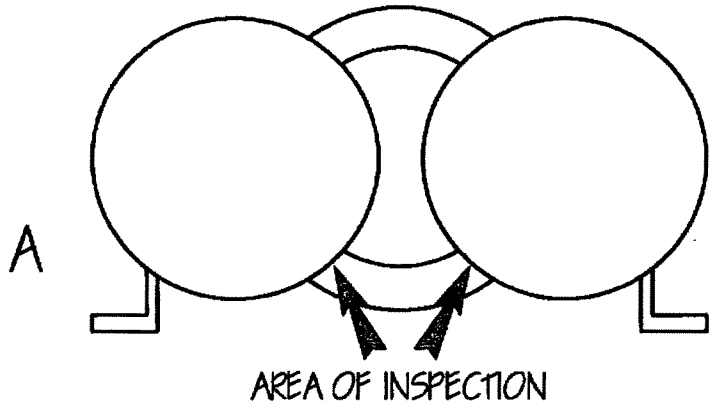
Early design (non-revised) tanks can be identified by the above measurements, and have a total of four (4) mounting/leg tabs. Early design tanks have no gussets (see illustration A.)

1. Raise the bus on a hoist.
2. Use a flashlight with beam focus ability. Examine the bottom crossover tubes at the weld-line along the top quadrant. (See illustration for inspection area).

3. The first indication is hairline paint system failure at the edge of the weld where the tank barrel and the bottom tube are joined.
4. The second indication (progression) is an absence of paint along the weld line.

Please inspect the buses on the attached list immediately following the supplied procedures that are accompanying this letter. If your buses have the tanks as described in diagram "A" the tanks need to be changed. Contact EIDorado National immediately so tanks can be provided and replacement can be scheduled. If you buses have tanks as described in diagram "B" or "C" the tanks do not need to be replaced. Once you have determined which tank you have "A", "B" or "C" please fill out the attached sheet for each bus inspected and return it to:

6. **If leakage is detected, or if conditions described in step 4 are observed, the tank must be removed from service.** The tank should be evacuated (liquid and vapor) and remove the filling connection at the body. Plug unused hose and cap the fitting. Also disconnect the hose from the service valve (the hose that feeds the engine). Plug unused hose and cap the fitting. The vehicle may be run on the other propane tank while awaiting replacement.

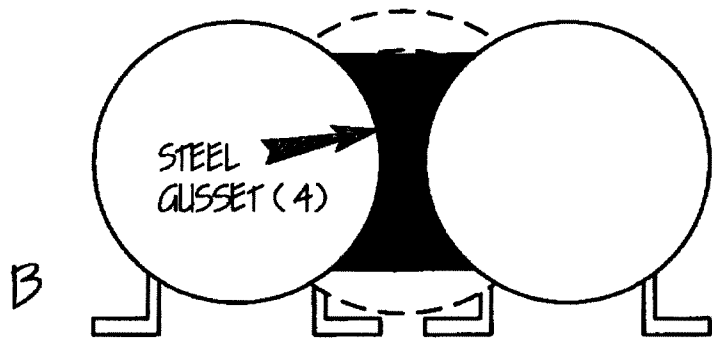
1) This bus has tanks as described in diagram “B” or “C” and they do not need to be replaced.
