## DCCBNA Recall Bulletin

### Exhaust Elbow Failures

**Subject: SAFETY DEFECT – Exhaust Elbow 070774434**

**Models:** Orion VII

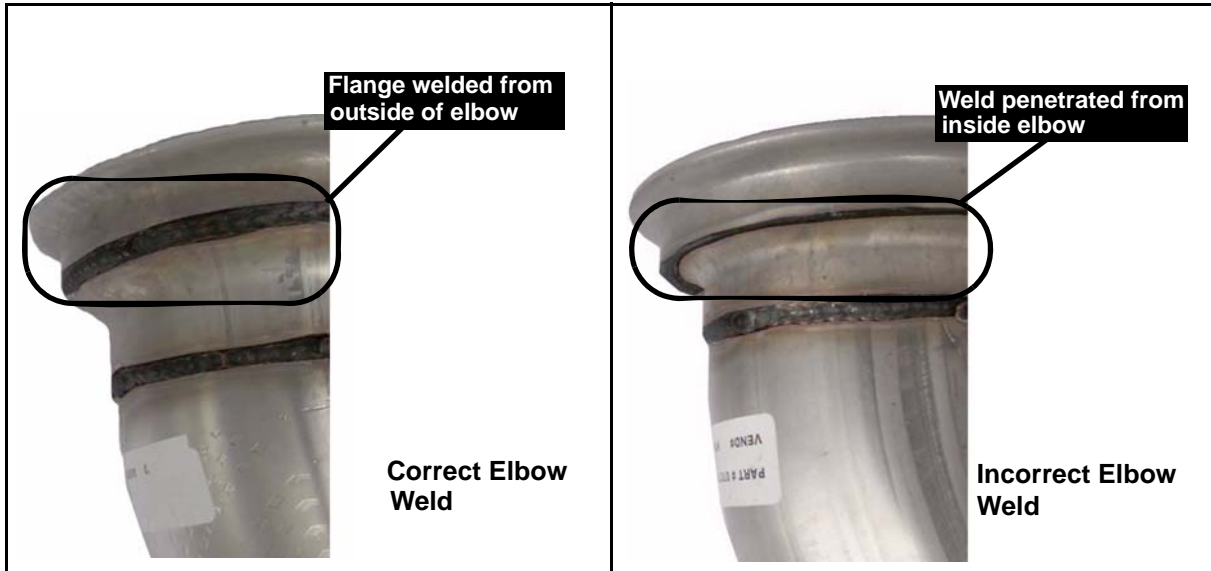
**Figure 1-2 Exhaust Elbow Welds**

**Defect:** A weld on an exhaust elbow, part number 070774434, was incorrectly manufactured.

5. Inspect exhaust elbow for correct welds. [See Figure 1-2](#)
  - a. If welds are found to be incorrect, exhaust elbow must be replaced. [See "Procedure" on page 4.](#)
  - b. If welds are found to be correct, no procedure needed, secure exhaust blanket clips, close engine compartment access door and turn battery isolator switch to the ON position.

1. Install new exhaust elbow **070774434** at the exhaust flex pipe.
2. Secure the two exhaust elbow v-clamps.
3. Close the engine compartment access door.
4. Secure exhaust blanket clips.
5. Turn battery isolator switch to the ON position.
