**Re: Defect Information Report – Supplemental Report No. 1  
07V-394, FL-511, FS65 Steering Pinch Bolt**

# Recall Campaign

October 2007  
FL511A  
NHTSA #07V-394

## Subject: FCCC FS/FB65 Steering Pinch Bolts

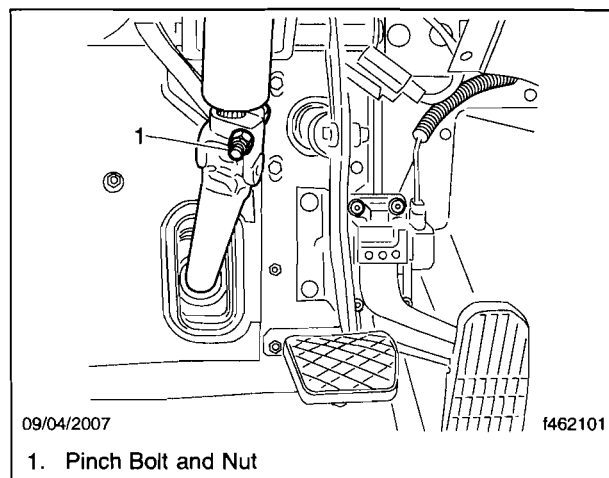
**Fig. 1, Pinch Bolt and Nut on Fixed Steering Column**

1. Shut down the engine, set the parking brake, and chock the tires.
2. Rotate the steering wheel until the nut is fully visible. See **Fig. 2**.
3. Check to see if Torque Seal® (paint) is present on the pinch bolt and nut.

If Torque Seal (paint) is present, please contact your dealer and make arrangements to take your vehicle in to have the Recall performed.

If Torque Seal (paint) is *not* present on the pinch bolt and nut, contact your dealer immediately for assistance. The vehicle should not be driven until the Recall is performed.

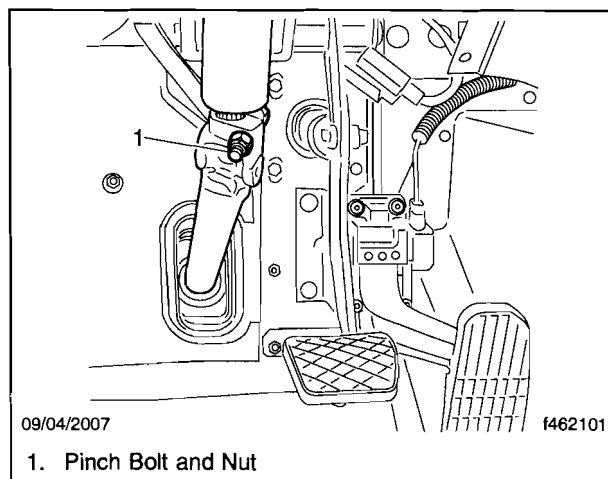
**Fig. 1, Pinch Bolt and Nut on Fixed Steering Column**

2. Shut down the engine, set the parking brake, and chock the tires.
3. Rotate the steering wheel until the nut is fully visible. See **Fig. 1**.
4. Check to see if Torque Seal® (paint) is present on the pinch bolt and nut. If Torque Seal is present, go to the next step. If Torque Seal (paint) is *not* present on the pinch bolt and nut, go to "Pinch Bolt Torque Procedure."

1. Using two wrenches, torque the pinch bolt and nut to 45 to 55 lbf-ft (61 to 75 N-m).
2. Apply an inspection mark using an oil-based paint marker such as a Uni Paint Marker® or an inspection lacquer such as F-900 Torque Seal® to denote that the pinch bolt and nut has been torqued. **See the note below for additional information.**
3. Write the Recall number FL511 on a blank, red completion sticker and attach it to the base completion label in the driver's area. If there is no base completion label first attach a base label.
4. Remove the chocks from the tires.
