Re: Safety Recall; Utilimaster 2007 Walk-In Delivery Vans; Campaign Number 07V-463  
Equipped with Square Halogen or Incandescent Headlamp Assemblies

## ***ATC Headlight Connector—Campaign Directive***

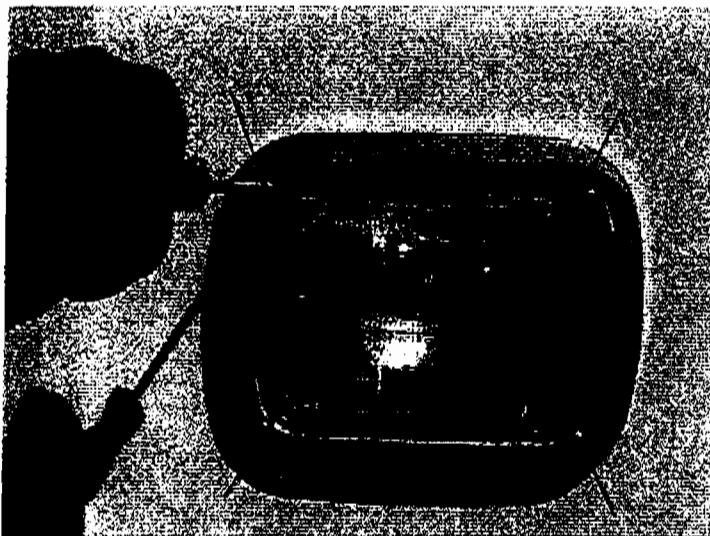
*Figure 10. Remove headlight bezel.*

1. Remove the headlight bezel held in place by (4) screws and set aside. Figure 10.

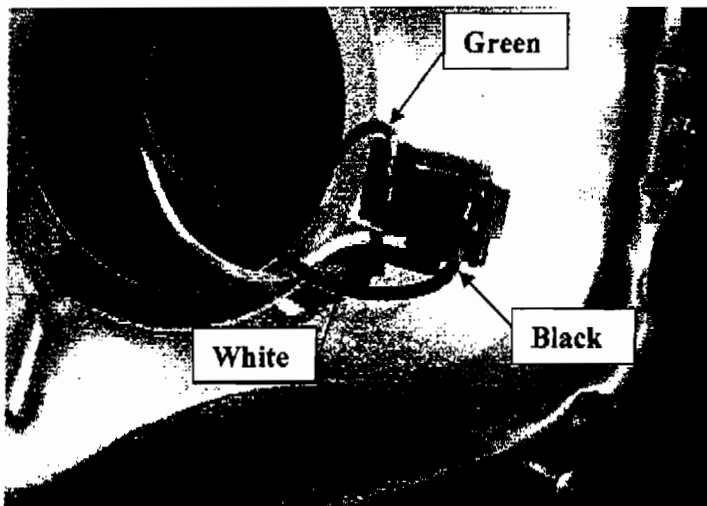
The electrical connector that attaches to the headlamp is mis-wired. The condition results in the headlamps operating at reduced brightness. Poor lighting from the headlights could cause reduced road visibility, increasing the risk of a crash.

*Figure 30. Correctly wired bulb connector. (Viewed from backside)*

4. Look at the orientation of the connector and the positions of the green, white and black wires, and compare with Figure 30 for the CORRECT locations.

**CAUTION:** Should the wiring be INCORRECT, the headlight bucket needs to be REPLACED!

5. Reassemble and order replacement buckets as necessary.
