BLUE BIRD

R07MS

Service Bulletin 34273

Instructions for Braun Corporation "Public and Private Use" Dual Parallel Arm Lift Threshold Sensitivity Evaluation and NHTSA Compliance Applicable for NL, NCL and NVL Series Lifts

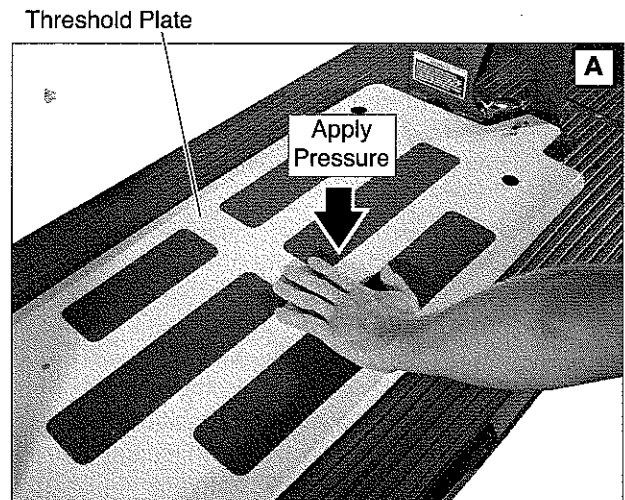
1. Turn Lift Power switch ON. Deploy the lift platform fully to the ground.
2. Apply hand pressure on the center of the threshold plate as shown in Photo A. The visual and/or audible threshold warning* should be activated when you push down.

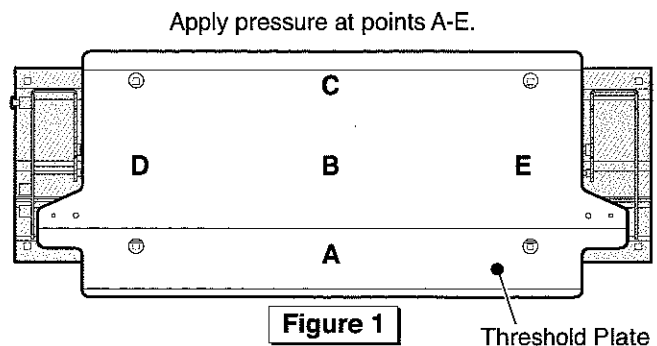
Repeat the sensitivity test procedure at positions A-E shown in Figure 1.

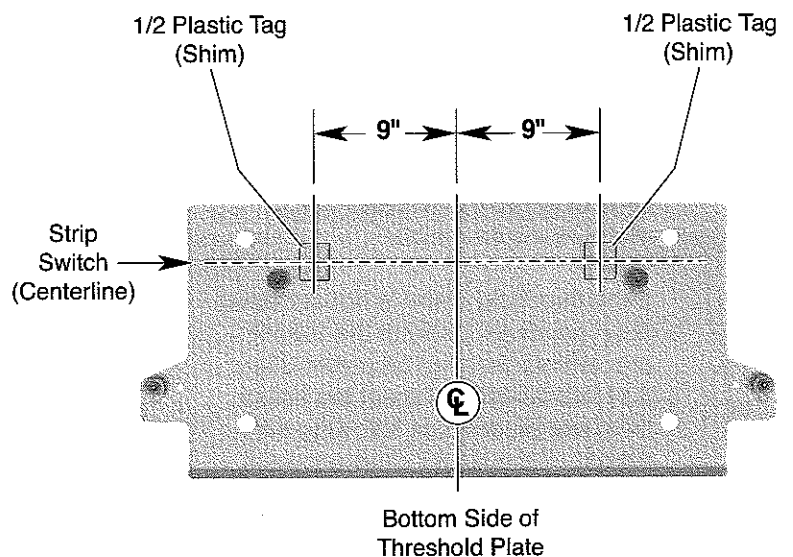
D

Turn threshold plate over. See Photo D. The strip switches typically leave an impression (mark) on the yellow plate from use. Use the impression of the inboard strip switch as a centerline for shim positioning (or measure to establish position).

Position each shim 9" from the center of the threshold plate (see Photo D). Align the tags with the strip switch centerline. Clean the surface as detailed below and affix the adhesive-backed tag to the plate (**press firmly**).

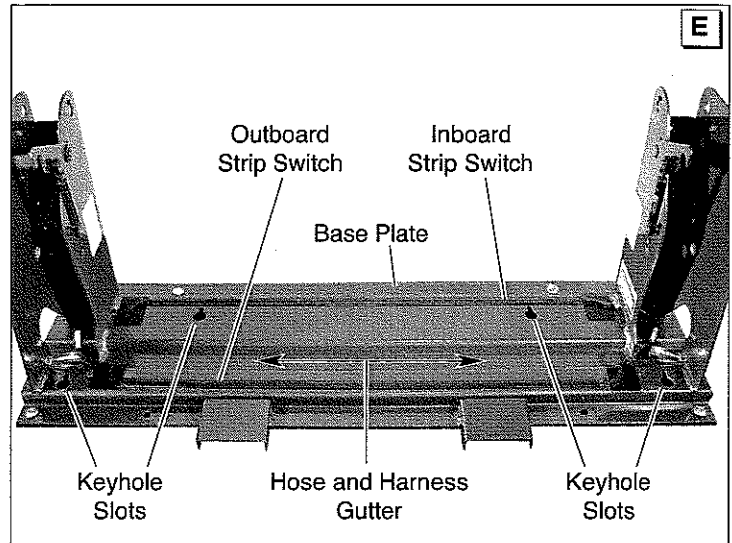
Ensure all hoses and wiring harnesses routed through the base plate gutter are positioned fully in the gutter and not located anywhere they could potentially interfere with activation of the tape switches. See Photo E.

4. Reposition the threshold plate (with shim). Align the keeper standoffs (studs) on the bottom of the threshold plate with the base plate keyhole slots. See Photos E, F and G. Insert studs and **carefully** slide the plate inward (engage slots fully).

Note: Spraying a light mist of glass cleaner (or other) to the strip switches will aid in the plate sliding easier into position. See Photos E, F and G.
