SAFETY RECALL NOTICE NUMBER 070009 (NHTSA RECALL NOTICE 07V-558)

Genie Industries, Inc. ("Genie") has decided that a defect which relates to motor vehicle safety exists in the assembly of the turntable bearing bolts on our TZ-34 and TZ-50 trailer mounted aerial work platform booms.

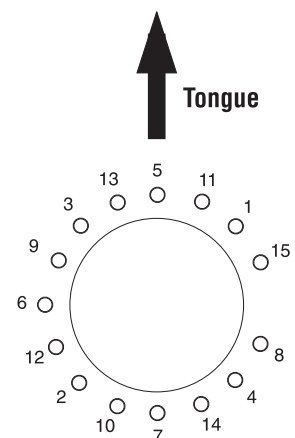
Illustration 3

Genie Industries, Inc. ("Genie") has discovered that certain TZ-34 and TZ-50 machines may have turntable bearing bolts that were under torqued. Bolts that were under torqued can come loose over time. This could cause the turntable lift structure to separate from the chassis, resulting in the platform falling.

7. Using a torque wrench, torque each turntable bearing bolt (Genie P/N 74712, 5/8-11 x 2.75 SHC) to 195 ft-lbs / 264 Nm. Mark each bolt as it is torqued. Use the torque sequence as shown in illustration 3.
