January 20, 2007

Safety Recall: Driver's Seat Position Sensor Harness Replacement

(Supersedes 07-002, dated January 19, 2007, to update the information marked by the black bar)

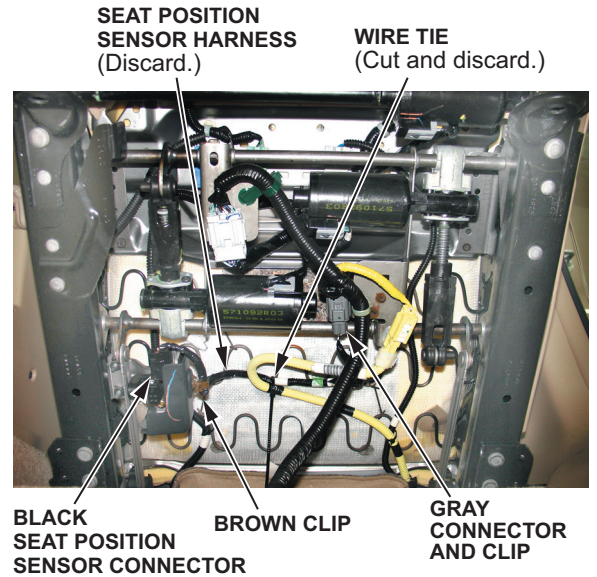
Because of an improperly routed driver's seat position sensor harness and an overtightened wire tie, the seat position sensor harness may be damaged. This may cause the SRS indicator to stay on with DTC 71-1x ("x" can be 0 thru 9 or A thru F) and result in the seat position sensor not being able to detect the seating position of the driver. This could affect the inflation pressure of the driver's front airbag.

9. Remove the original seat position sensor harness:

- Disconnect the black seat position sensor connector.
- Remove the brown clip from the seat position sensor cover.
- Cut and discard the wire tie.
- Disconnect the gray connector, and remove the clip from the seat frame.

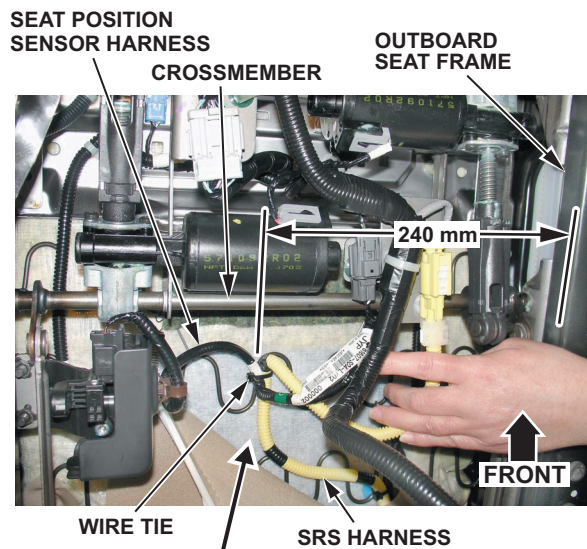
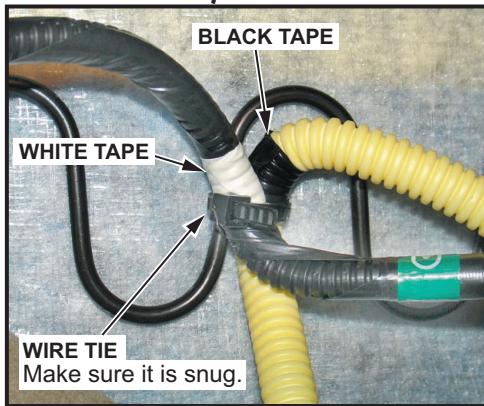
NOTE: If the wire tie is improperly attached, adjusting the seat could damage the seat position sensor harness.

11. Attach the new wire tie:

- The wire tie must be placed around the white tape on the seat position sensor harness, the black tape on the SRS harness, and the correct seat spring.
- The correct seat spring is located behind the front crossmember bar and 240 mm from the outboard seat frame.
- Fasten the wire tie to the straight section of the seat spring, not the curved part.
- The wire tie should be snug. If the wire tie deforms the corrugated tubing, it is too tight. If you can slide a pencil in between the seat position sensor, the SRS wires, and the wire tie, it is too loose.
