**MONACO**  
COACH CORPORATION

**VEHICLE SAFETY DEFECT SERVICE BULLETIN**

**Recall Campaign 07V010000 US Units**

**Re: Safety Recall - Frame Extension**

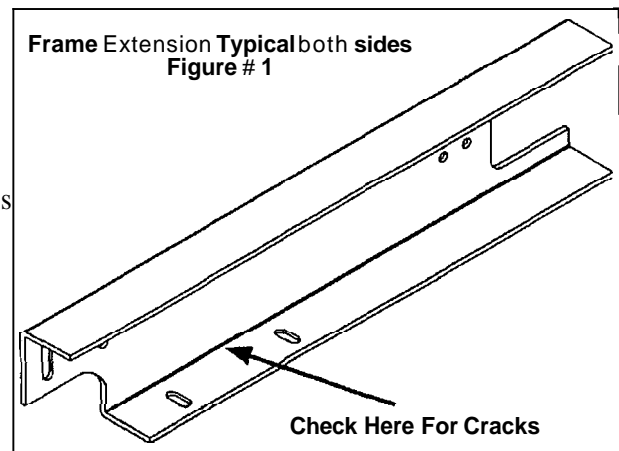
1. Check and document what the Vehicle tows and the equipment used (I.E. Hitch Extender, Drop Shank, Weight distribution head assembly, Car or SUV, Cargo or Box Trailer, Brake control or brake buddy or none)
2. Carefully inspect the hitch, especially the mounting bolts and frame extension area both sides (See Figure # 1).

3. If the hitch is bent or if the bolts are sheared and caused damage to the mounting bolt holes, we recommend hitch replacement
4. If the frame is bent at the point the hitch is mounted:
  - A. Unbolt and remove the hitch.
  - B. Return the frame to its original location by using a cutting torch and or clamps.
  - C. If any cracks present in frame extensions, grind and weld back together.
5. Verify Receiver is either a Reese or Hidden Hitch. There are 2 separate reinforcement kits by manufacture for mounting hole alignment.
6. Support or clamp the hitch to the Frame extensions and remove the old mounting hardware (or reinstall receiver, if removed in prior steps).
