RECALL: Fuel Tank Replacement

Land Rover LR3 (LA) VIN: 5A000360 to 5A342827 – Specific Vehicles

Bulletin SRE07-02

Subject: SAFETY RECALL P001 - NTSA # 07V-011

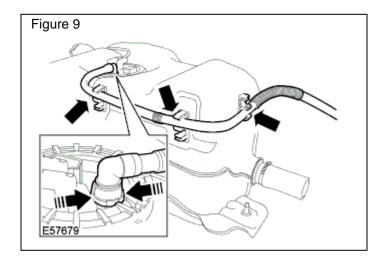
- 15. Remove the fuel tank vent line (Figure 9):
 - Disconnect the quick release connector.
 - Remove from the 3 clips.
- 16. With assistance, remove the fuel tank from the transmission jack.
