# TOYOTA CUSTOMER SERVICES

Volume: XIV  
Number: TC07-002  
Date: 01/18/2007  
 Action  
 Retain  
 Information

SUBJECT: SAFETY RECALL (SPECIAL SERVICE CAMPAIGN) – 70B  
(FRONT SUSPENSION LOWER BALL JOINTS)

**SPECIAL SERVICE CAMPAIGN 70B (SAFETY RECALL)**

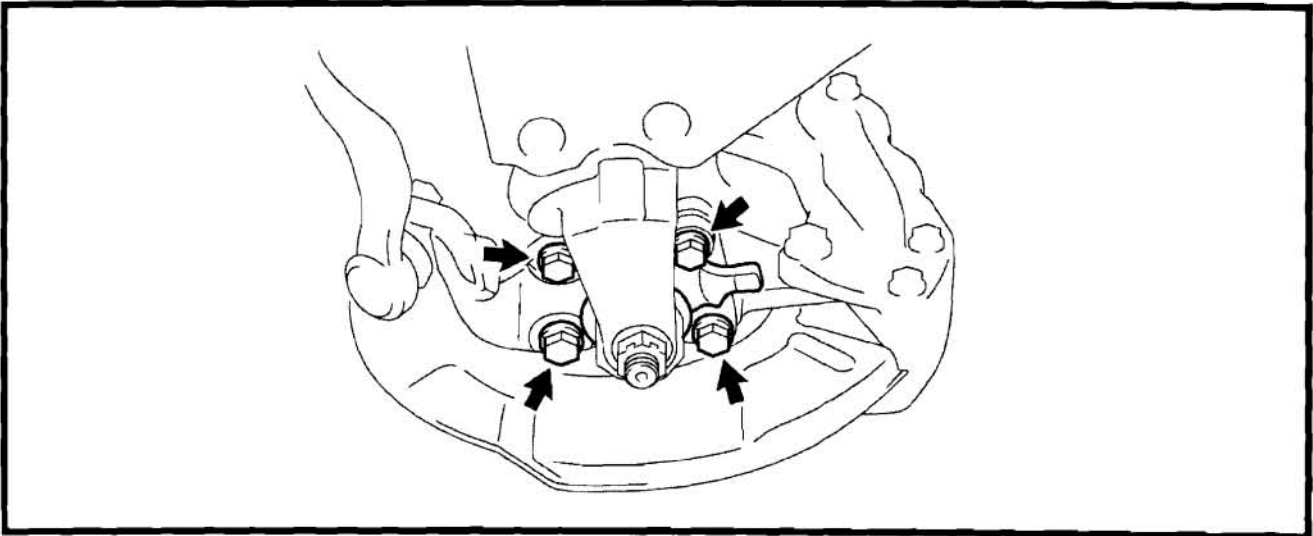
1) Confirm the size of the "**Front Suspension Lower Ball Joint Bolt Heads.**"

a) For vehicles with...

**14mm bolt heads**

- Vehicle is involved in SSC 50J. See SSC 50J instructions and replace the ball joint. Please note previous instructions for 50J should be replaced with revised ones available from TIS which reflect that 17 mm bolt heads fall under 70B.

**17mm bolt heads**

- The vehicle is involved in SSC 70B.
- Proceed to **A. REPLACE THE FRONT SUSPENSION LOWER BALL JOINTS** on page 5.
