**GM SERVICE AND PARTS OPERATIONS
DCS1764
URGENT - DISTRIBUTE IMMEDIATELY**

Subject: 06217A – Noncompliance Recall
Head Impact Protection
Service Procedure and Claim Information Revised

Models: 2005-2006 Chevrolet Cobalt Coupe
Without Roof-Mounted Side Impact Airbags

SUBJECT: Head Impact Protection

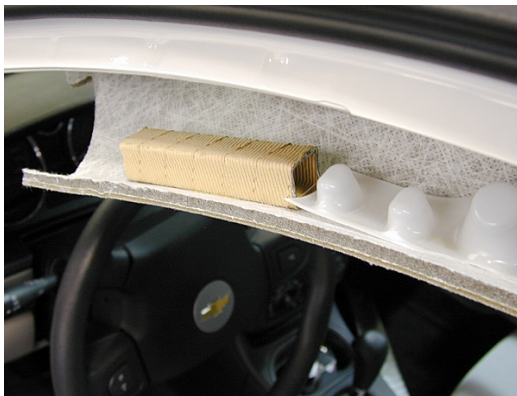
1953869

Interim Production Repair

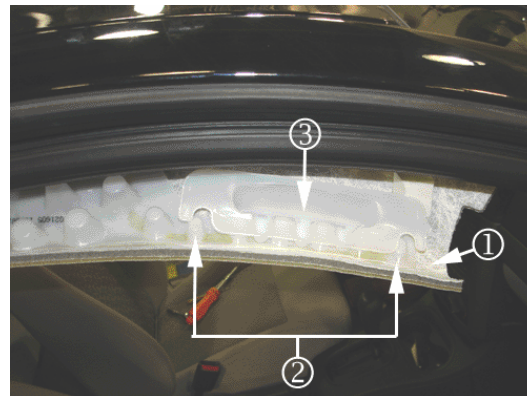
1883691

Current Production and Service Repair
