## Safety Recall: DC-DC Converter Output Cable Is Pinched by IPU Lid

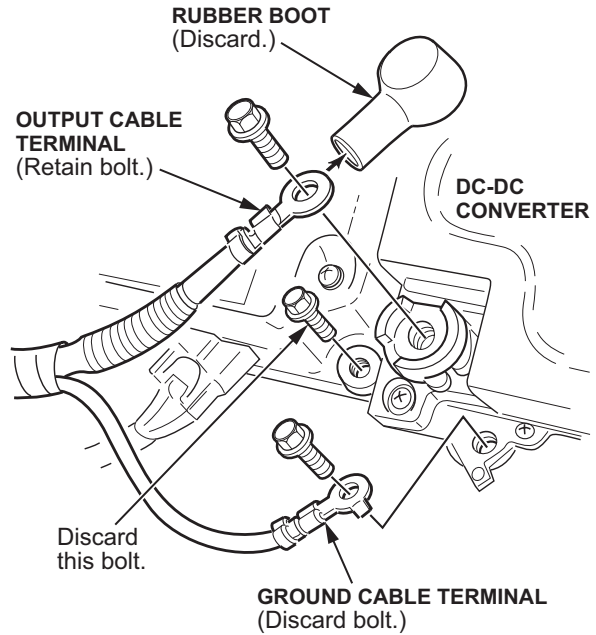
- Check the position of the DC-DC converter output cable terminal. If the terminal sticks up from the DC-DC converter, bend it down slightly with your hand.
- Disconnect the output cable terminal (one bolt). Remove the rubber boot covering the terminal.
