Dealer Service Instructions for:

Safety Recall 602

Front Wheel Bearing and Hub Assembly

2006 (DR) Dodge Ram 1500 Series Pick Up Truck

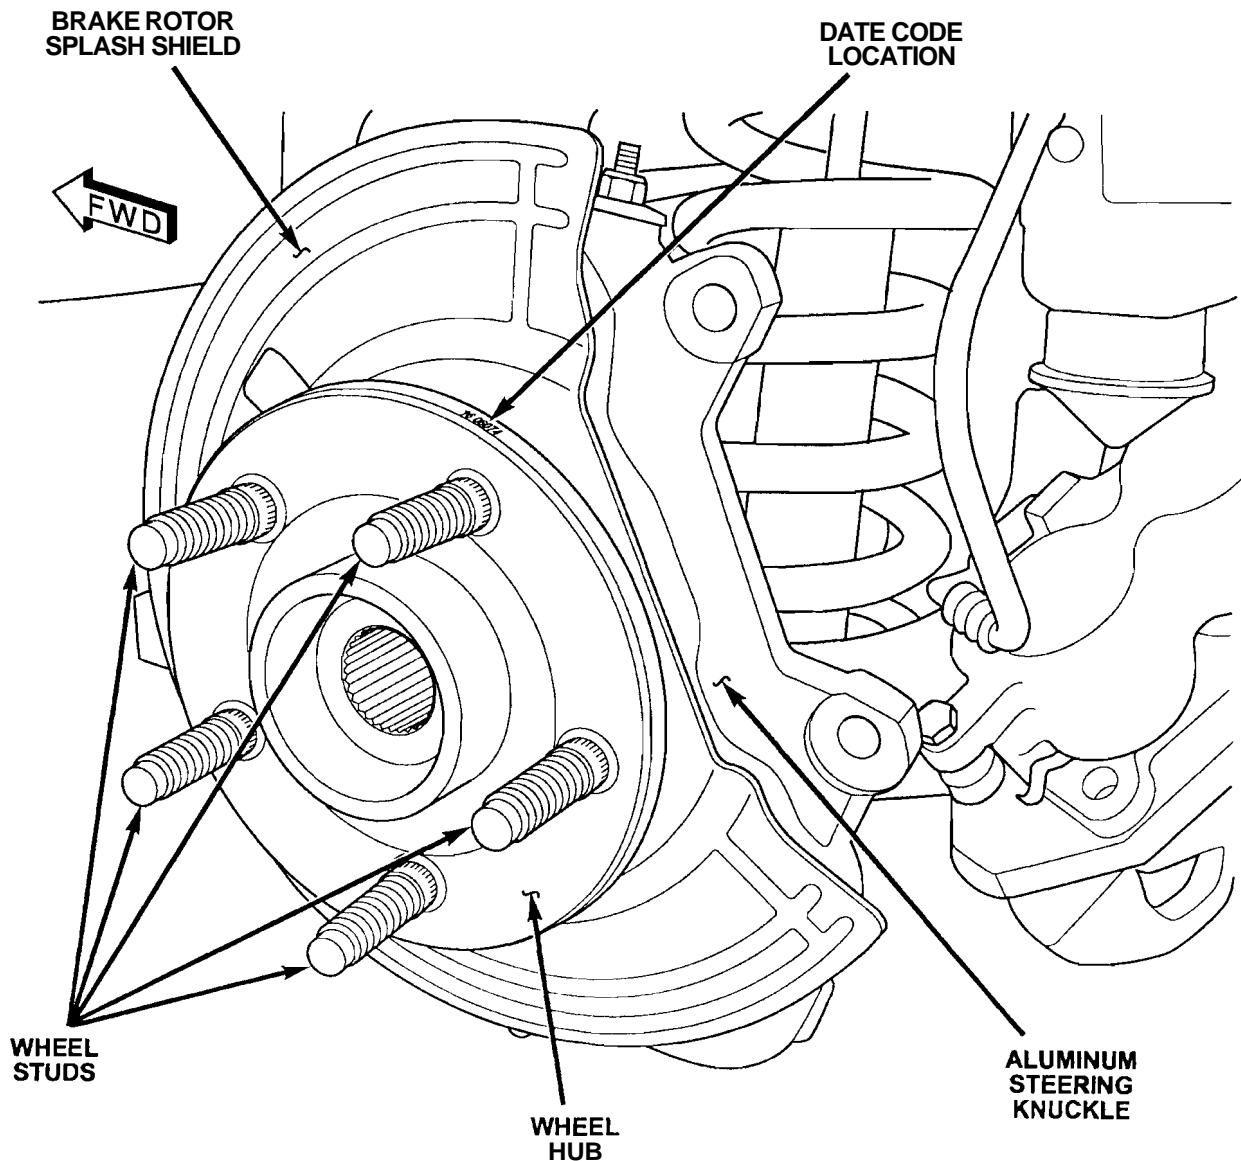
Figure 2 – Left Side Shown

5. Inspect the 5 digit date code on both front wheel hubs. The date code is located on the outside edge of the wheel hub flange (Figure 2).

- If the date range on the hub is 05306 **through** 06074, or is unreadable, replace the hub and bearing assembly. Continue to **Section B – Hub and Bearing Replacement**.

- If the date range is 05305 or lower, **OR** 06075 or higher, the bearing and hub assembly is good. Continue to **Section C. Assemble After Bearing and Hub Inspection or Replacement**.
