TECHNICAL BULLETIN

No: P004
Issue: 1
Date: 30 Jul 2007

RECALL: Brake Light Switch

Freelander (LN)

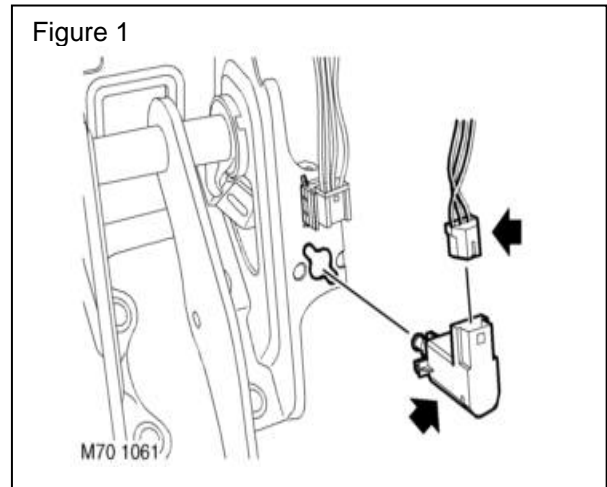
Situation: Land Rover has identified a concern with the brake light switch on 2002 to 2005 model year Freelander vehicles in North America. The brake lights may remain illuminated even when the brake pedal is not depressed. Improperly functioning brake lights could result in the vehicle being involved in a crash.

The brake light switch may become maladjusted either as a result of an incorrect setting procedure at vehicle manufacture or as a result of the switch mounting bracket flexing. This allows the switch contacts to remain permanently connected because the switch has reached the full extent of its travel.

1. Open the driver's door.
2. Move the driver's seat fully rearward.
3. Remove the installed brake light switch as follows: (Figure 1)
 - Disconnect the brake light switch electrical connector.
 - Rotate the switch 45 degrees counter-clockwise to release the bayonet fitting.
 - Remove the switch from the bracket aperture.
