### **Subject: WVC-13 Passenger Front Seat Wiring Safety Recall**

Subaru of America, Inc. has initiated a voluntary Safety Recall to inspect and possibly repair the passenger front seat wiring on approximately 7,000 2006MY Forester and Impreza models. Campaign code WVC-13 has been assigned to this Safety Recall.

**APPLICABILITY:** 2006MY Subaru Forester & Impreza      **NUMBER:** WVC-13  
**SUBJECT:** Front Passenger Seat Wiring                      **DATE:** March 2007

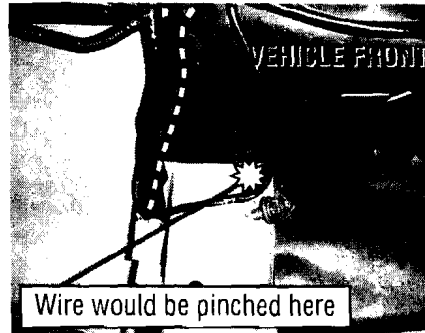
- Pull up the floor carpet to inspect a section of the subject body wiring harness from the clamping point located behind the shifter console down to the front passenger seat slide rail as indicated in the photo to the left, on the next page.
- Check visually and with your fingers to confirm that the wire is not located around the seat bracket area as indicated by the arrow in the photo to the right, on the next page.

The proper wire location (not pinched) is indicated by broken lines in the photo to the right, below.

- If the wire was found to be pinched, proceed to the "Wiring Repair Procedure" section, below.

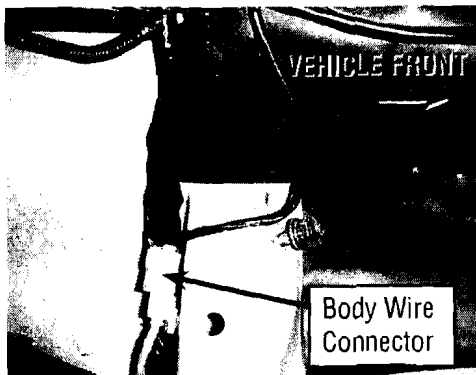
**Note:** Check if the wire is pinched at the seat rail and damaged.

5. Repair the wire according to the extent of damage as indicated below.

(1) When only the surface of the wire covering is damaged only: Wrap electrical tape around the damaged portion. proceed to Step 7.

(2) When the core wire is cut or damaged: Cut and remove the damaged section of wire, as illustrated.
