SUBJECT: Vehicle Safety Recall - SC0318
Chalmers Suspension

SC318

Subject: Adjustable Torque Rod Replacement — Chalmers Rear Suspension

#20061110

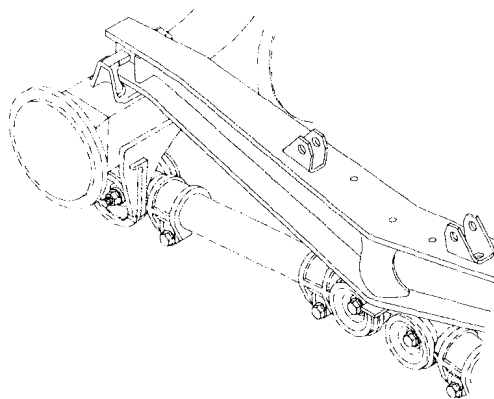
Figure 1

1. Ensure vehicle is safely parked. Apply parking brakes and chock wheels. Ensure proper safety lock out procedures are followed.
2. Identify the adjustable torque rods (See Fig. 1)

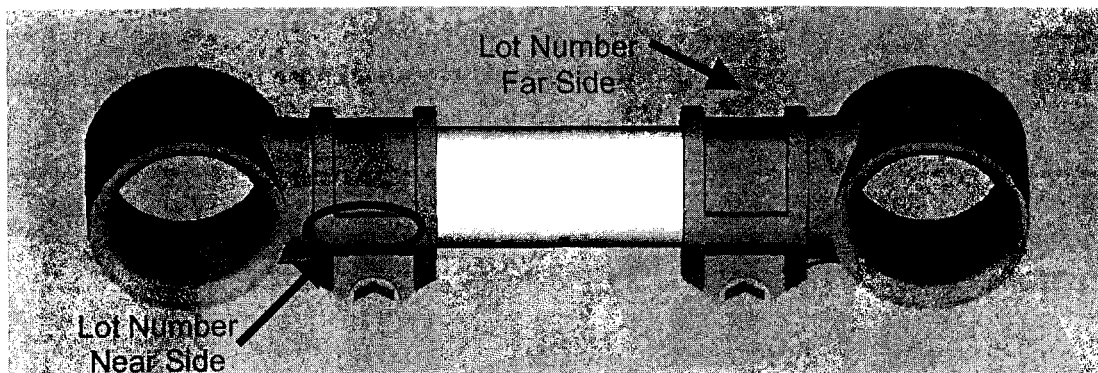
Figure 3

Typically, when inspecting an adjustable torque rod installed on a truck, the left side casting will have the Lot number on the near side and the right side casting will have the Lot number on the far side (See Fig. 3).
