March 2, 2007

SUBJECT: Safety Recall **05S28** - Supplement **#10**
 Certain 1994-1996 Model Year Bronco, 1994-2003 F-150 through F-550, 1997-2002 Expedition, 1998-2002 Navigator, 2002-2003 Blackwood, 1994-1996 E-150/250/350, 1996-2002 E-450, 2002-2003 E-550, 2000-2003 Excursion, and 1998 Explorer and Mountaineer gasoline or natural gas engine vehicles equipped with Speed Control – Speed Control System Modification

Safety Recall 05S28 - Supplement #10

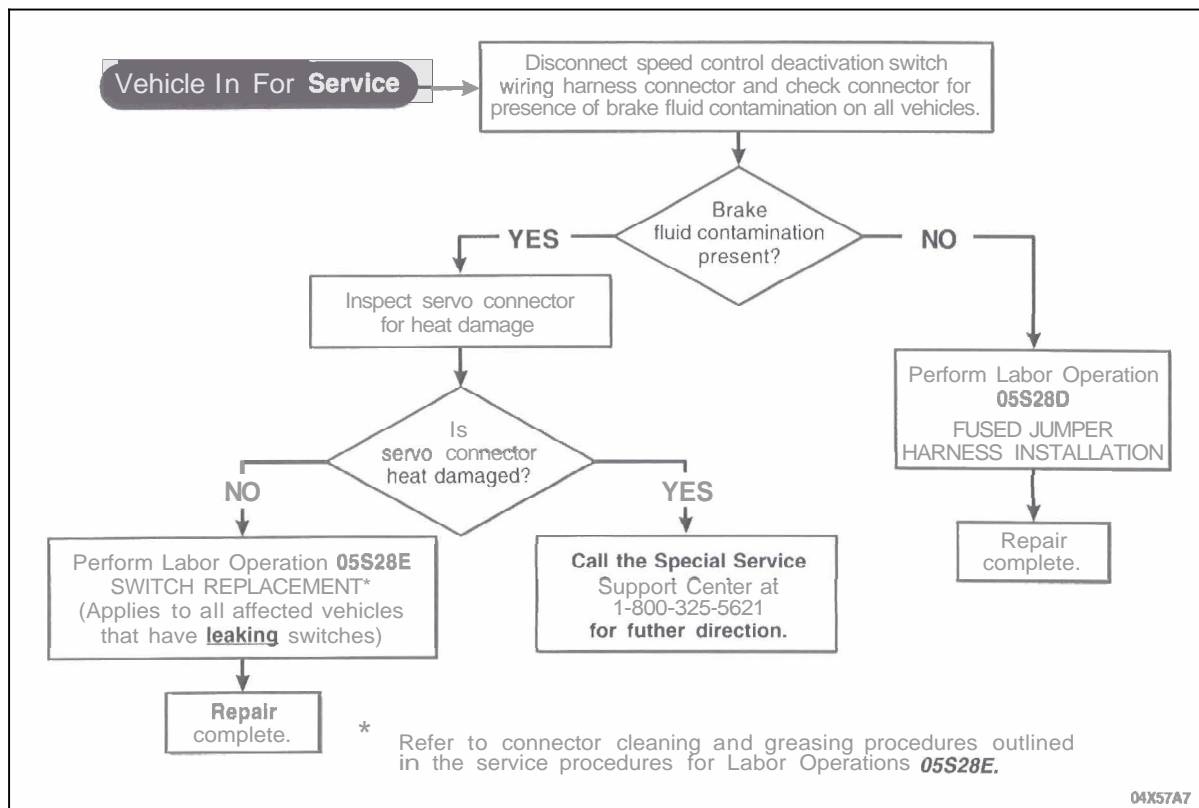
FIGURE 1

This program involves inspecting the speed control deactivation switch connector for presence of brake fluid and then determining which repair to perform. A flow chart has also been developed to help direct you to the proper repair. See Figure 1.

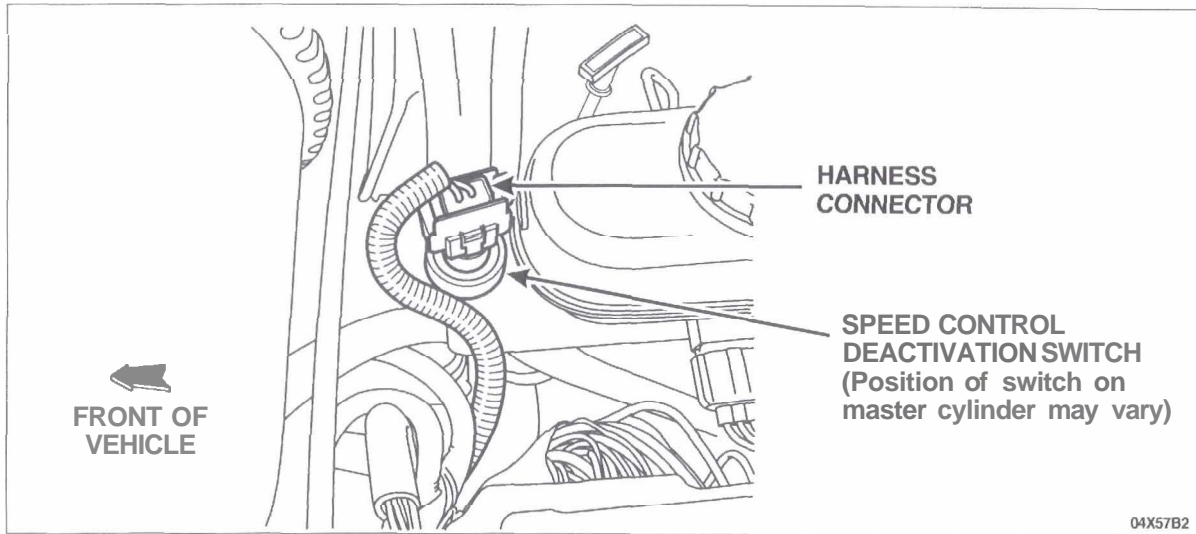
FIGURE 2

2. Disconnect the speed control deactivation switch located on the brake master cylinder and inspect the harness connector for the presence of brake fluid. See Figure 2.
 - If no brake fluid is present:
 - install the fused jumper harness (Labor Operation D).
 - If brake fluid is present, DISCONNECT THE SPEED CONTROL SERVO AND INSPECT THE VEHICLE HARNESS CONNECTOR FOR HEAT DAMAGE. See Figure 3.
 - If no heat damage is found at the speed control servo connector (even if there is presence of brake fluid in the connector), proceed to Labor Operation E.
 - If the speed control servo connector is heat damaged, call the Special Service Support Center at 1-800-325-5621 for further instructions.
