Reference: NHTSA Identification Number 07V-092

# **Safety Recall G07**

## **Test and Reprogram Instrument Cluster**

**2004-2006 (HB) Dodge Durango**

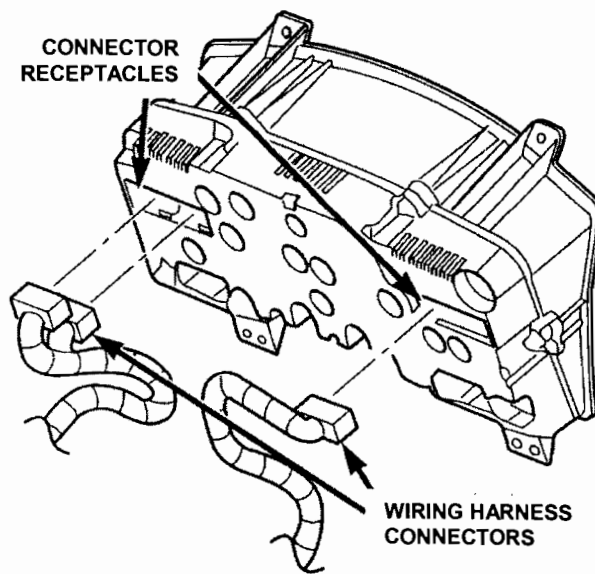
Figure 3

13. Use the following procedure to relocate the yellow (w/orange tracer) wire in cavity number C11 of the white instrument panel cluster connector to the open cavity number C2 of the same connector:

**NOTE: The new cluster software will reassign the control circuit for the dome lamp to a different pin on the cluster connector. Therefore, the dome lamp wire must be relocated so that the dome lamp will function after this repair is performed.**

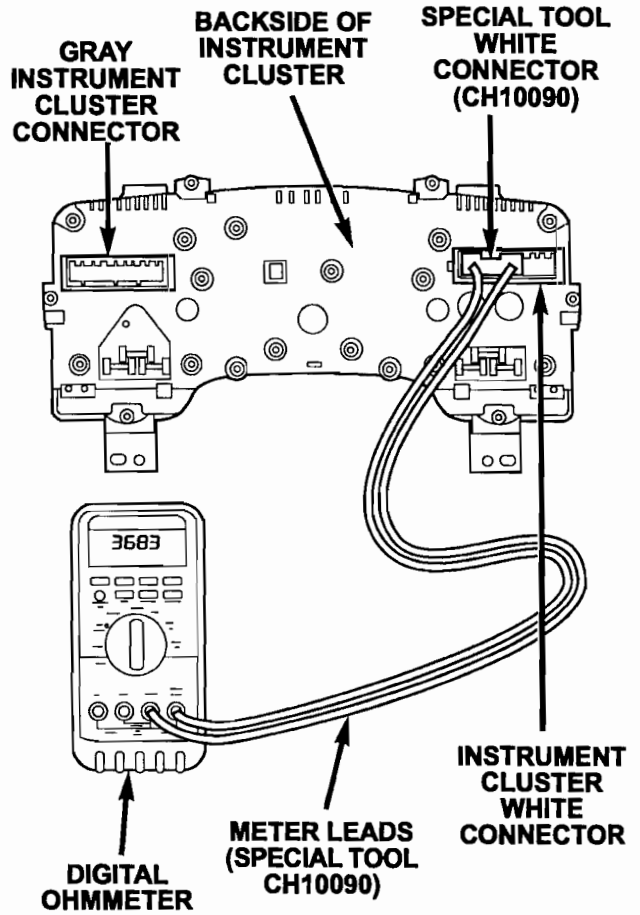
Figure 7

- If the resistance reading is **more than 2000 Ohms**, the cluster is good. Continue with Step 15 of this procedure.

- If the resistance reading is **less than 2000 Ohms**, the cluster must be replaced. Follow the procedure below to replace the instrument cluster:

- b. Connect the white connector of Special Tool CH10090 to the white instrument cluster connector (Figure 7).

- c. Connect the wires of Special Tool CH10090 to the ohmmeter terminals (Figure 7).
