Reference: NHTSA Identification Number 07V-092

Safety Recall G07

Test and Reprogram Instrument Cluster

2004-2006 (HB) Dodge Durango

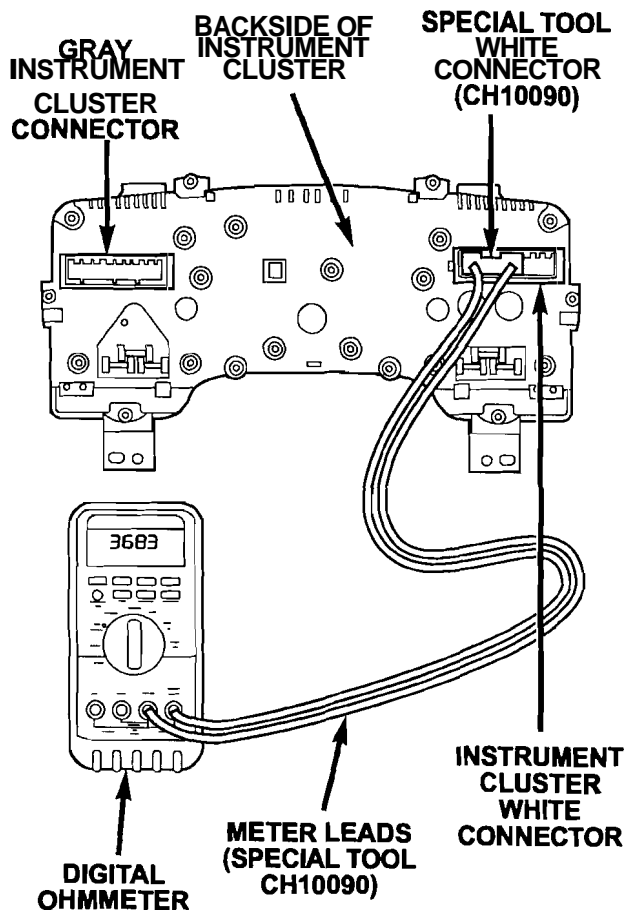
Figure 7

- If the resistance reading is more than **2000** Ohms, the cluster is good. Continue with Step 15 of this procedure.

- If the resistance reading is less than **2000** Ohms, the cluster must be replaced. Follow the procedure below to replace the instrument cluster:

b. Connect the white connector of Special Tool CH10090 to the white instrument cluster connector (Figure 7).

c. Connect the wires of Special Tool CH10090 to the ohmmeter terminals (Figure 7).
