IMPORTANT RECALL INFORMATION #70219

SUBJECT: RECALL CAMPAIGN #70219
American Eagle and American Tradition Battery Seal

**RECALL
BULLETIN:
70219**

SUBJECT:
Installing Battery
Compartment
Seal

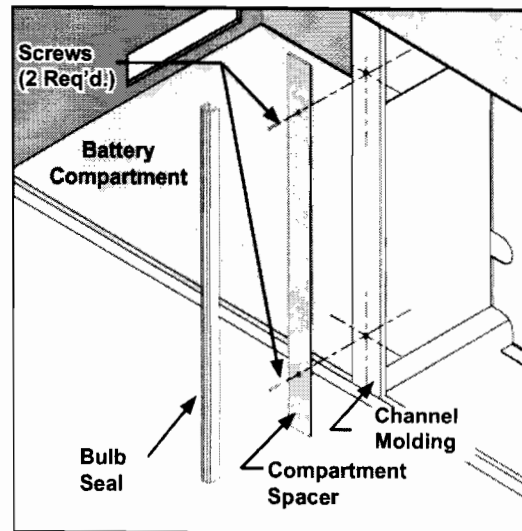
Figure 1

The compartment containing the coach batteries needs to be sealed from spark-producing devices in order to prevent the ignition of gases produced by the batteries.

3. Remove the screws fastening the metal channel molding to the edge of the battery compartment wall. (See Figure 1.) Discard the screws.

4. Position the Compartment Spacer so that it is aligned with the channel molding. See Figure 1.
5. Fasten the Compartment Spacer and the channel molding to the end of the compartment wall using screws included with the repair kit. Tighten screws.
6. Prepare the surface of the new Compartment Spacer for application of a bulb seal by wiping with an adhesion promoter, such as Pro-Bond.
7. Remove the protective strip from the back of the new bulb seal and apply the seal to the surface of the Compartment Spacer using firm pressure. Make sure that the bulb seal adheres to all areas of the surface of the Compartment Spacer.
8. Close and open the compartment door to ensure operation and to verify the seal makes contact with the back side of the door. Correct as necessary.
9. Turn on battery disconnects.
