| Date: 03/2007<br>Bulletin #: 46 004 07 (012) <b>R</b> | | Source: SI 09/2007<br>BMW Motorrad USA<br>Service and Technical | | | | |

### **\*\*Recall 07V-151: Replacing Frame Bottom Section\*\***

**Subject:** Replacement of frame bottom section of F650 GS/Dakar models

**Model:** F 650 GS (R13 facelift), F650 GS Dakar (R13 facelift)

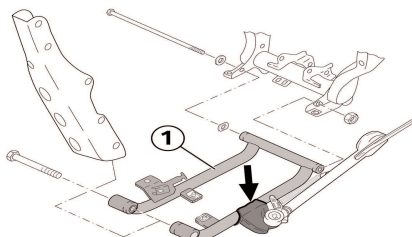
**Details:** On account of a deviation from standard procedure in a welding process, the weld (arrow) between side-stand pivot mount and frame bottom section might not be accurately positioned.  
In order to ensure that the side stand retains its load-bearing capability under all circumstances, frame bottom section (1) of each motorcycle affected will need to be replaced.

The frame bottom section (1) of each of the motorcycles affected has to be replaced.
